# DEAN VALLEY REGENERATION

## **Dean Valley Walkway - Second Phase Feasibility Study Report**

Prepared by Land Use Consultants: September 2018

# Dean Valley - Second Phase: Walkway Feasibility Study

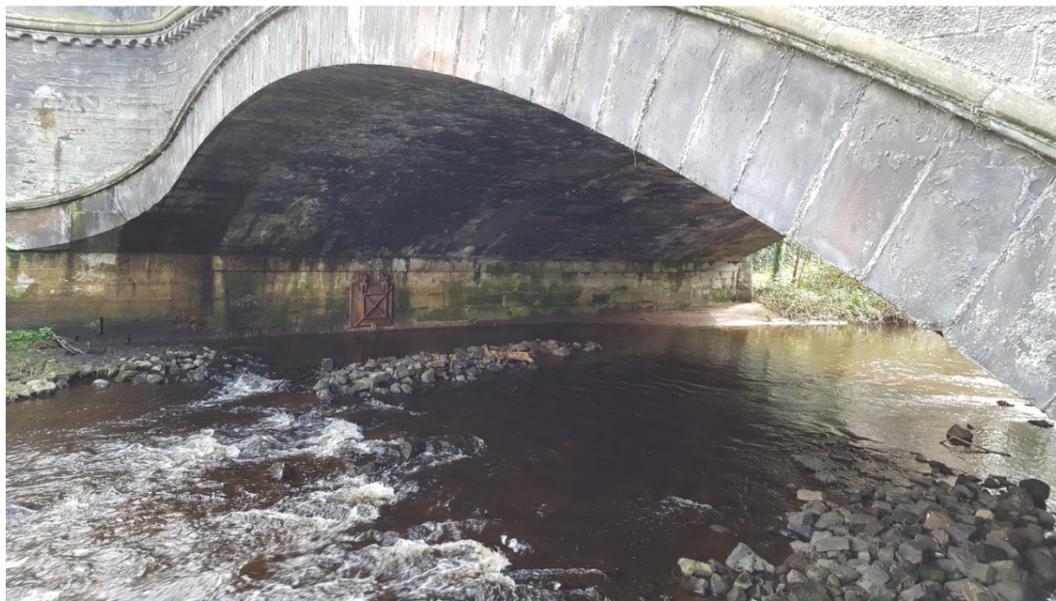
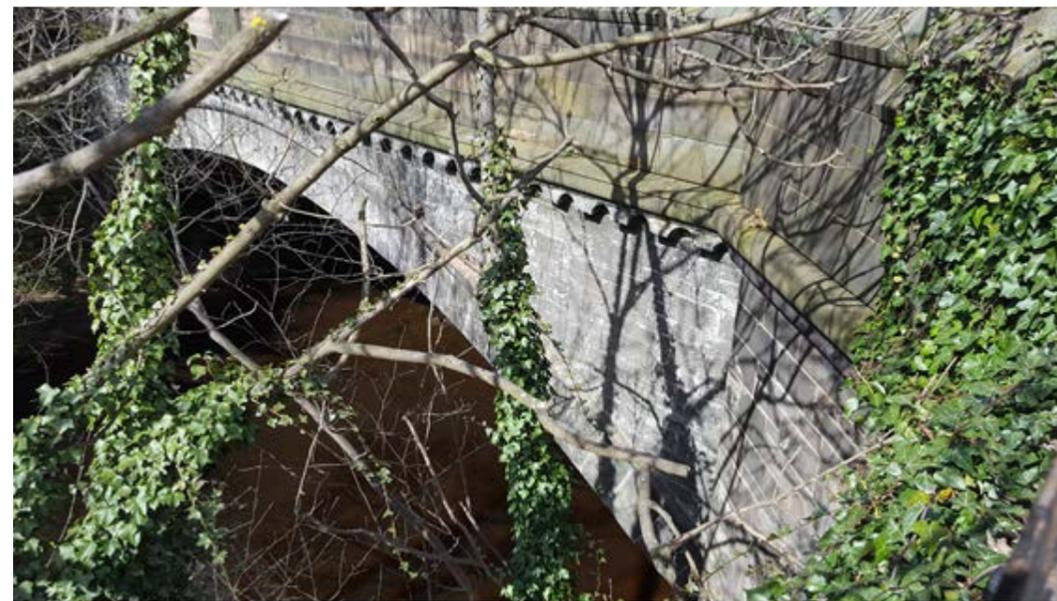
- 4.6 This road bridge is a single span stone arched bridge which has been continuously maintained by the council roads department over time. The main structure appeared to be in good condition with no signs of structural movement or deflection.
- 4.7 The parapets appeared straight and aligned and there was no apparent movement of the voussoirs, soffit, abutments or the top surface (left photo). On the west side at the base of the parapet there is an old root of cut-back vegetation still protruding from the jointing (right photo).

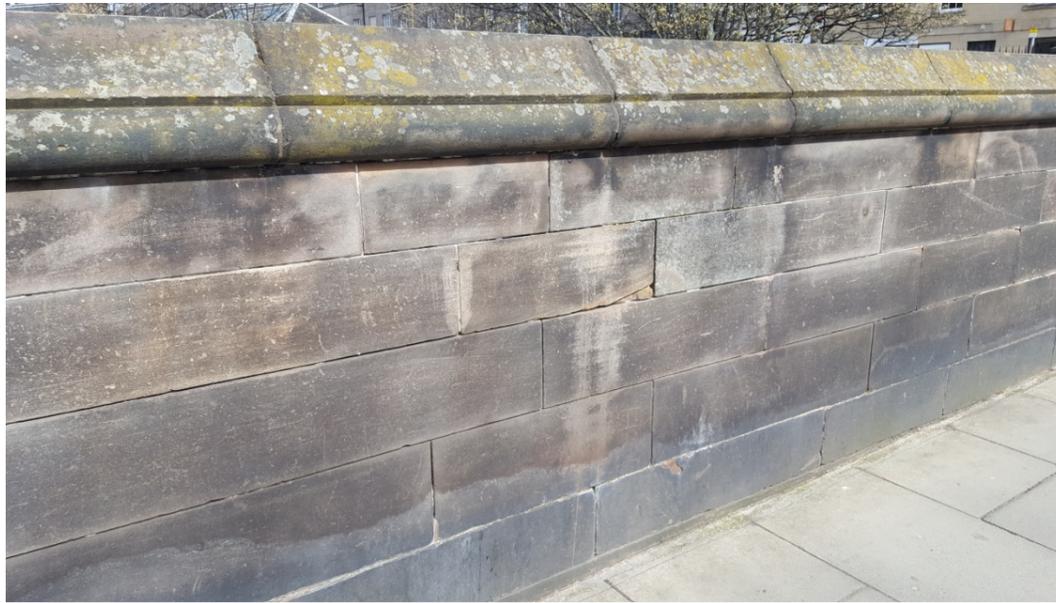
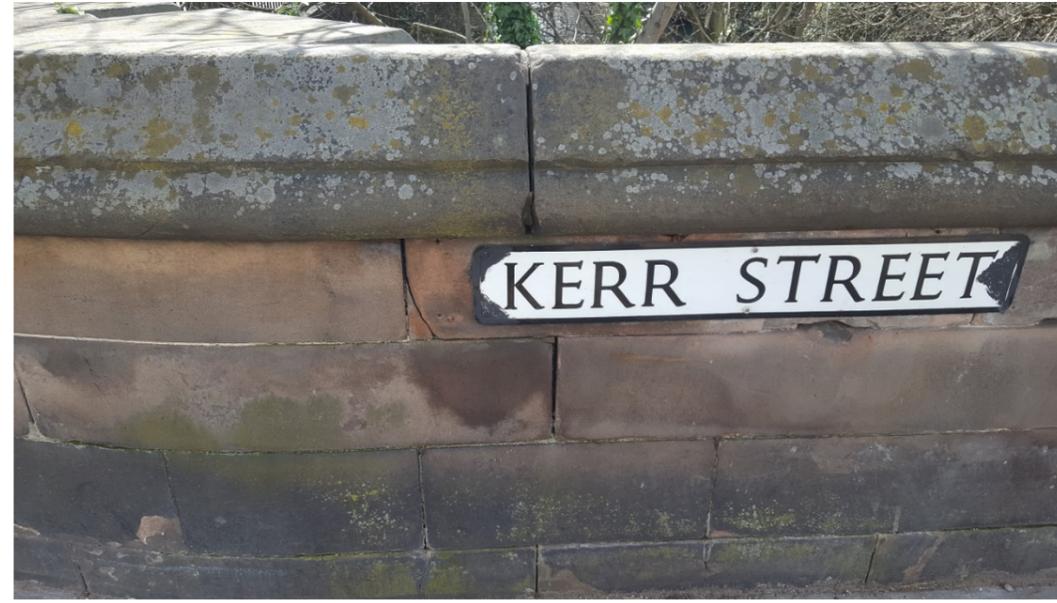
- 4.8 There are some chips in the main stones of the parapets but these are not of structural concern and do not affect the weatherproofing, structural integrity or condition of the bridge:

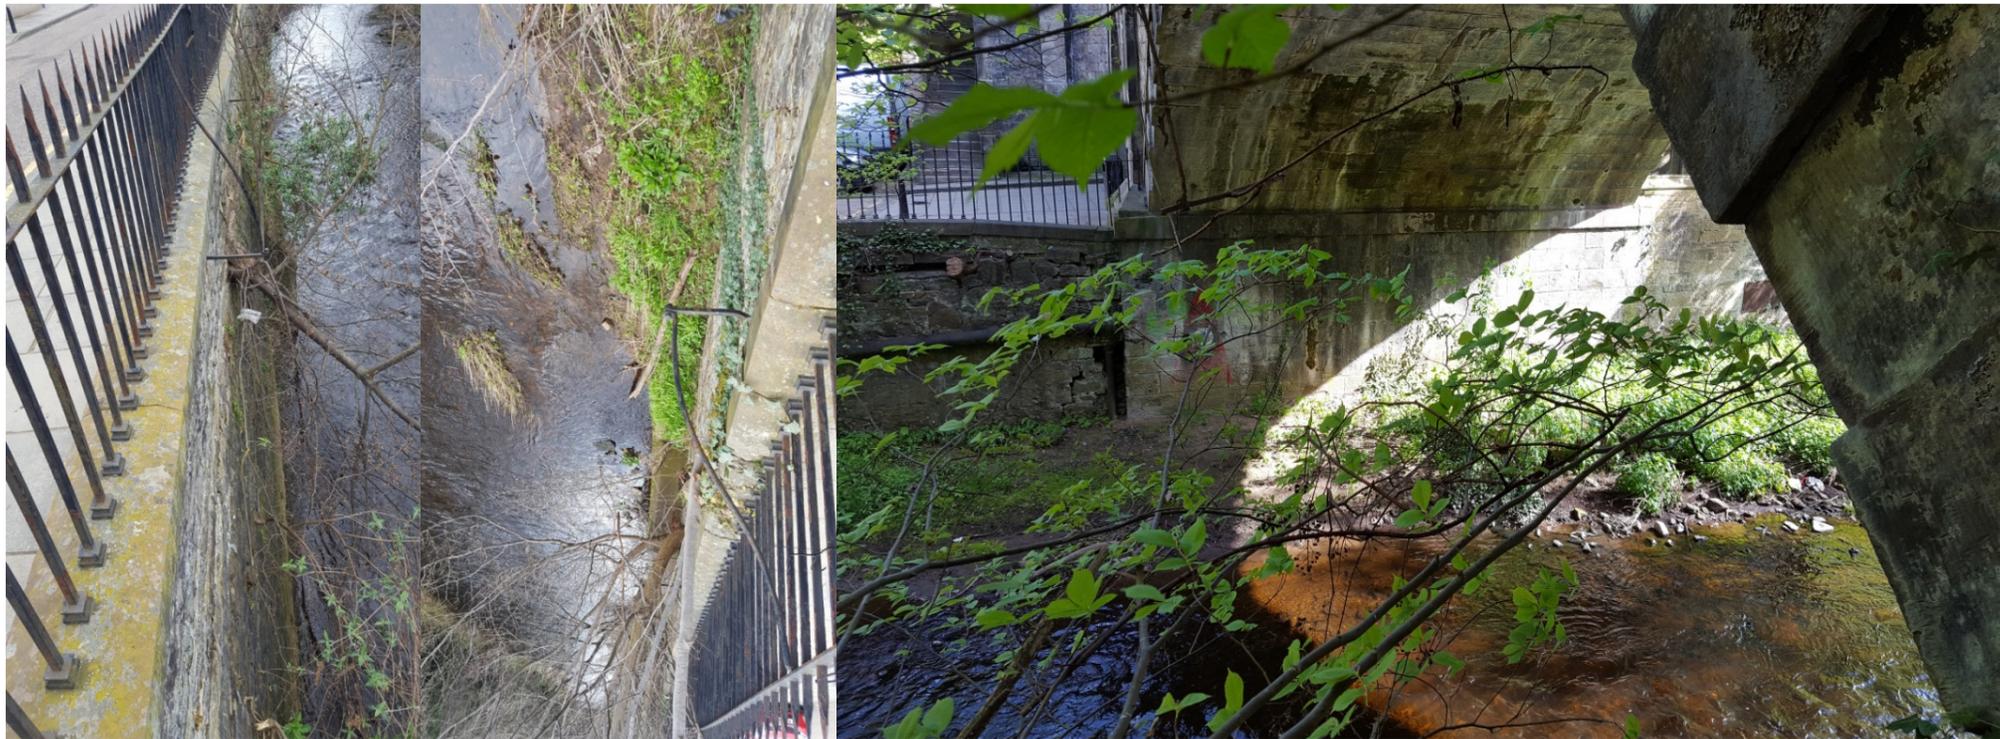
- 4.9 The main stone river wall is generally in good condition but there are some obvious defects in numerous areas.
- 4.10 The main challenge facing the wall is vegetation growth, with large rooted plants and trees protruding from joints in the masonry. These roots will be affecting the core of the wall and will need to be chased out through localised rebuilding on a sustained campaign of remedial works:

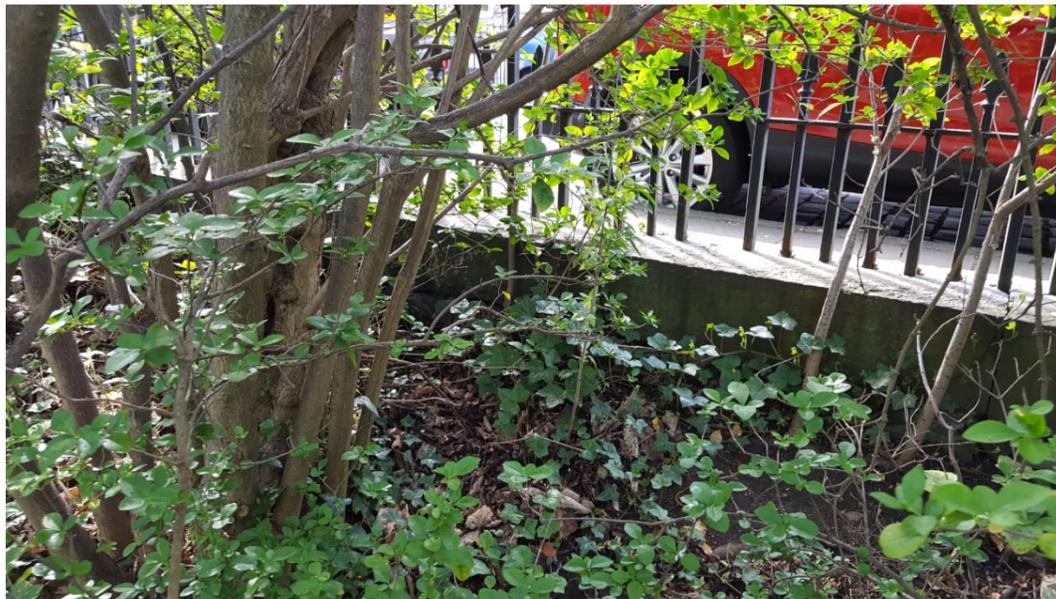
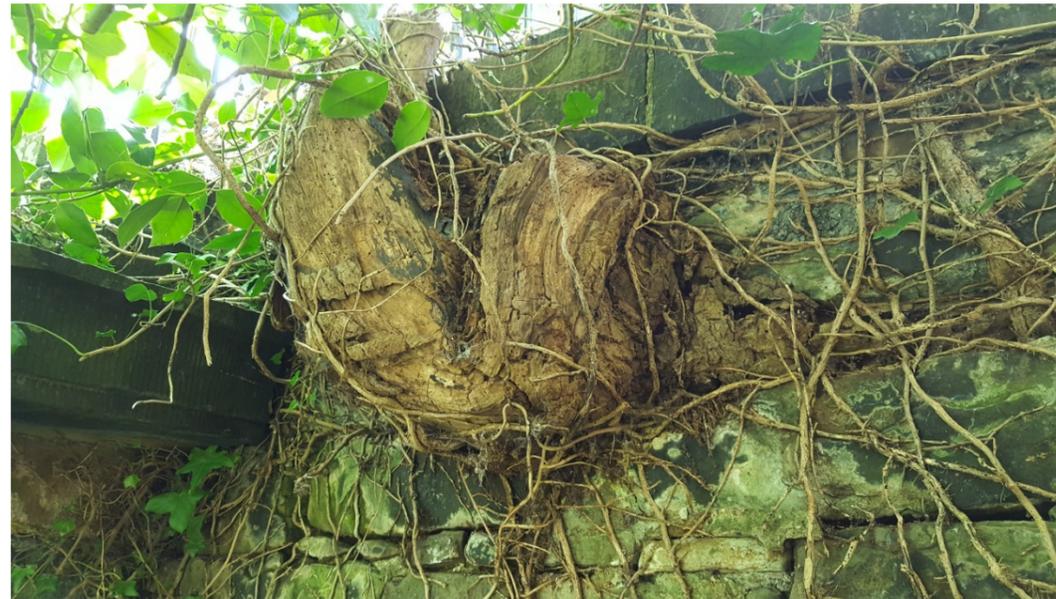
4.13 The railings and base stones appear to be off-plumb in many lengths of the wall. There are numerous instances of missing metalwork in the railings and also corroded sections of both balusters and cross-ties. In one location a tree has grown around the main tie bar and the railing has been adjusted to fit around the tree.

4.12-4.14	Dean Terrace (road wall)	Railings and base stones appear to be off-plumb in many lengths of the wall. There are numerous instances of missing metalwork in the railings and also corroded sections of both balusters and	Repair and restore iron railings	Necessary	See railings section

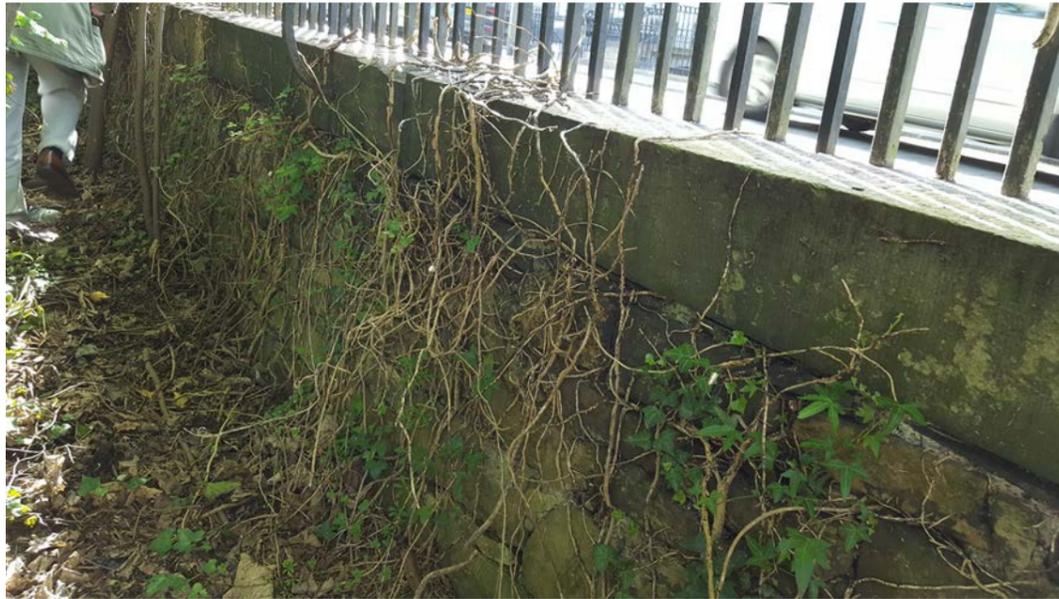
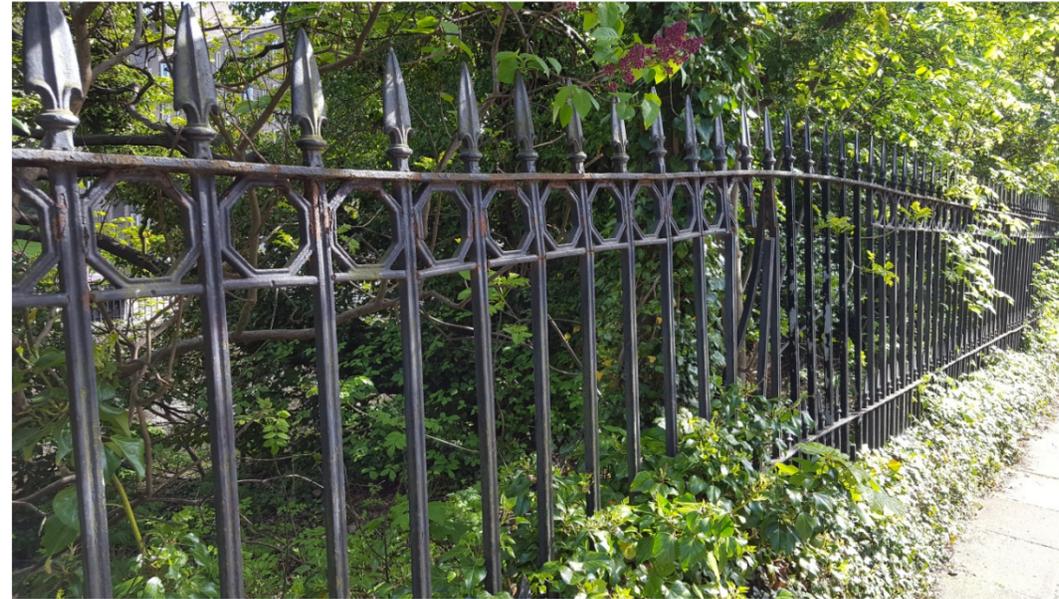
- 4.14 The base stonework and adjacent footpath appears to have moved and settled along the length of the wall, which may be due to root displacement. Some further investigation into the condition of the wall and the footing of the cope stonework should be made by trial pitting and some stone removal.

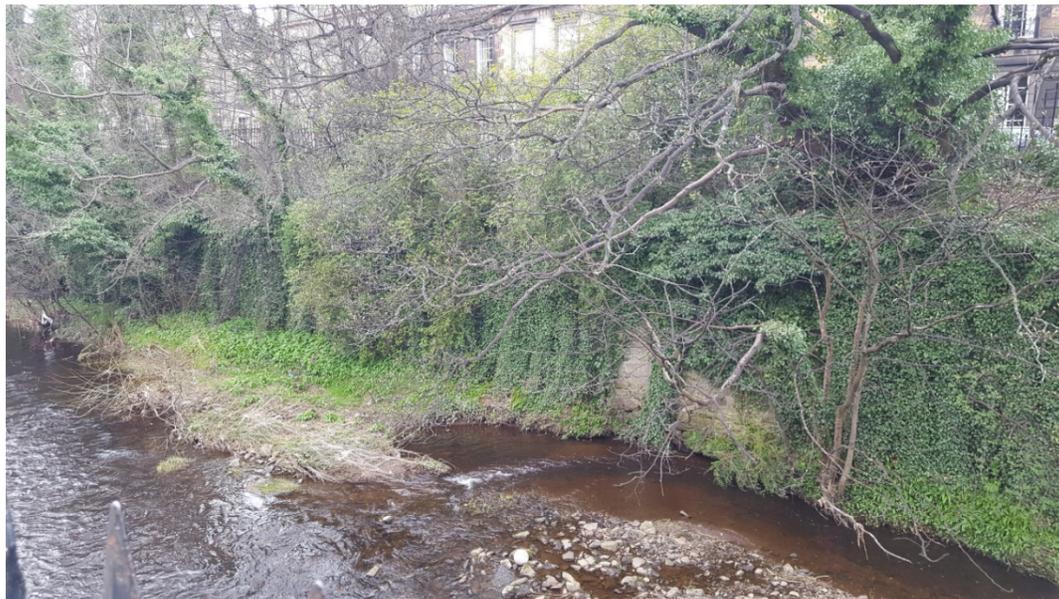
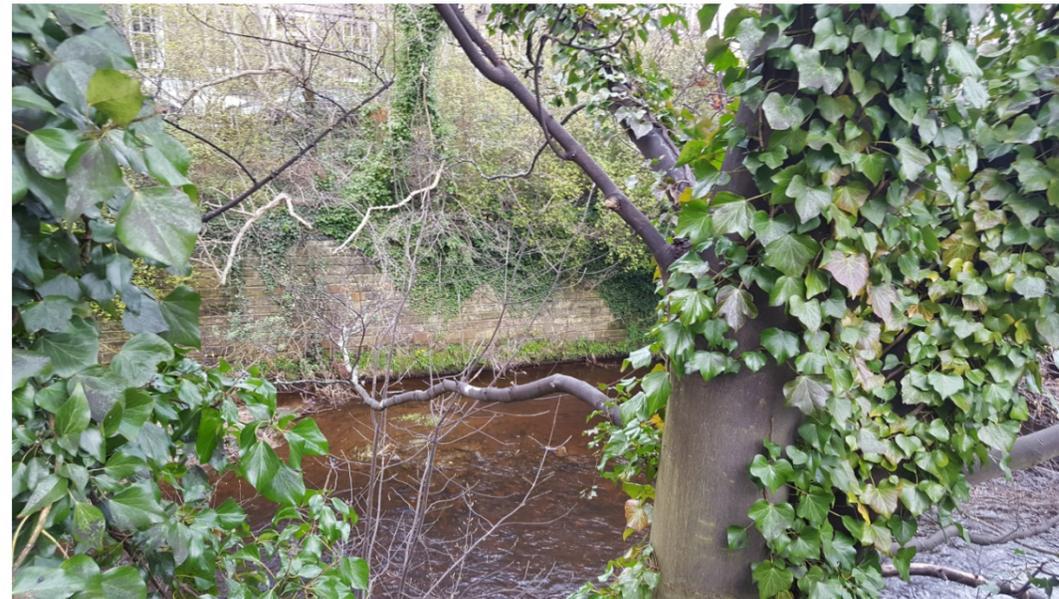
- 4.15 This wall immediately adjacent to the river is on abandoned land and is not actively managed by any parties. It exhibits similar issues to the South Bank Wall, with vegetation growth from within the wall representing the biggest threat to its structural integrity. There are some missing stones which should be re-instated by indentation.

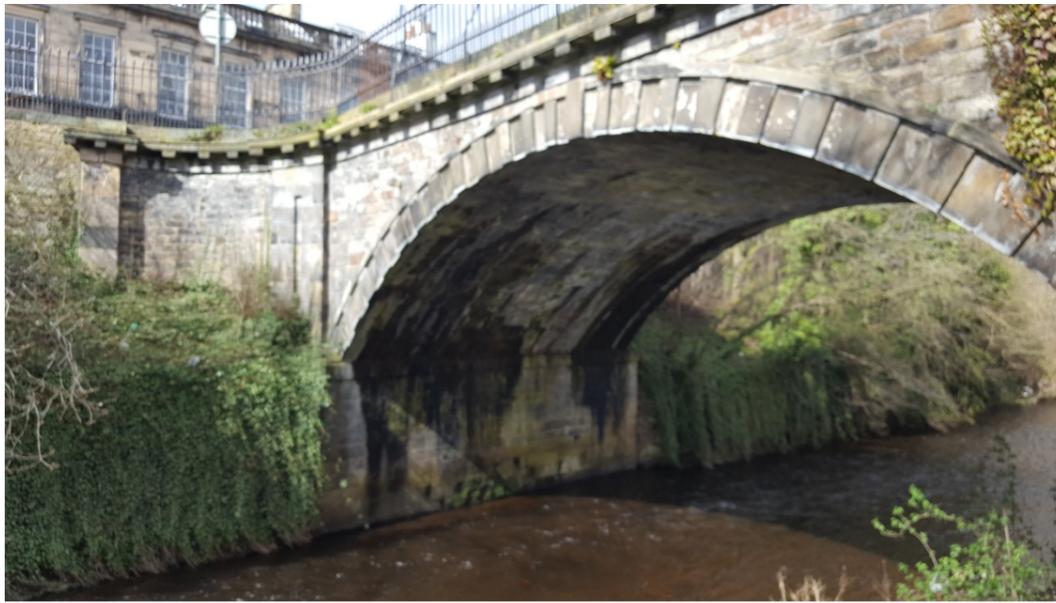
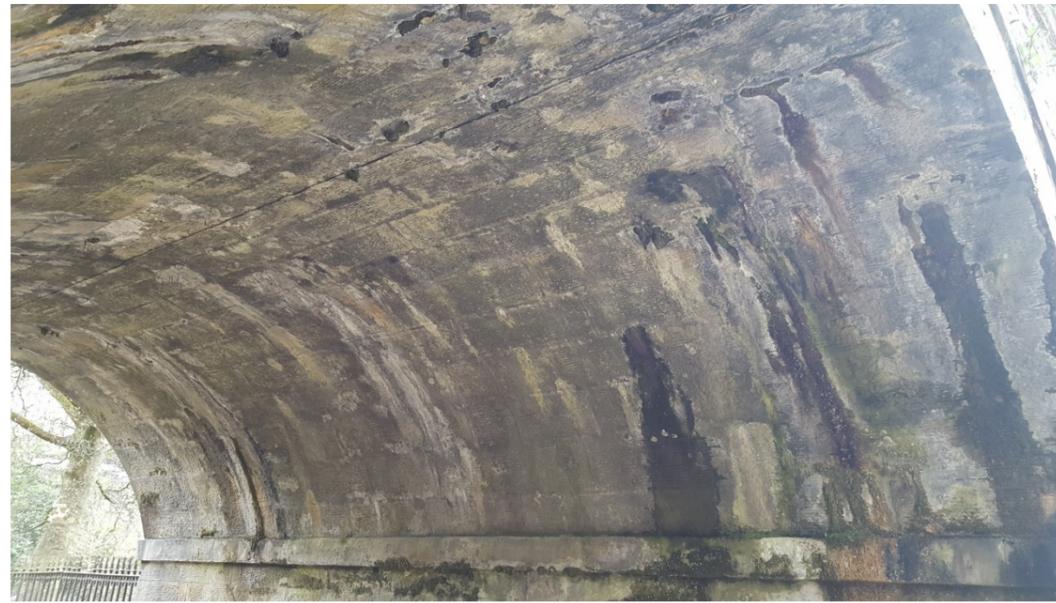
- 4.16 This road bridge is a single span stone arched bridge which has been continuously maintained by the council roads department over time. The main structure appeared to be in good condition with no signs of structural movement or deflection.

4.17 The parapets generally appeared straight and aligned and there was no apparent movement of the voussoirs, soffit, abutments or the top road surface.

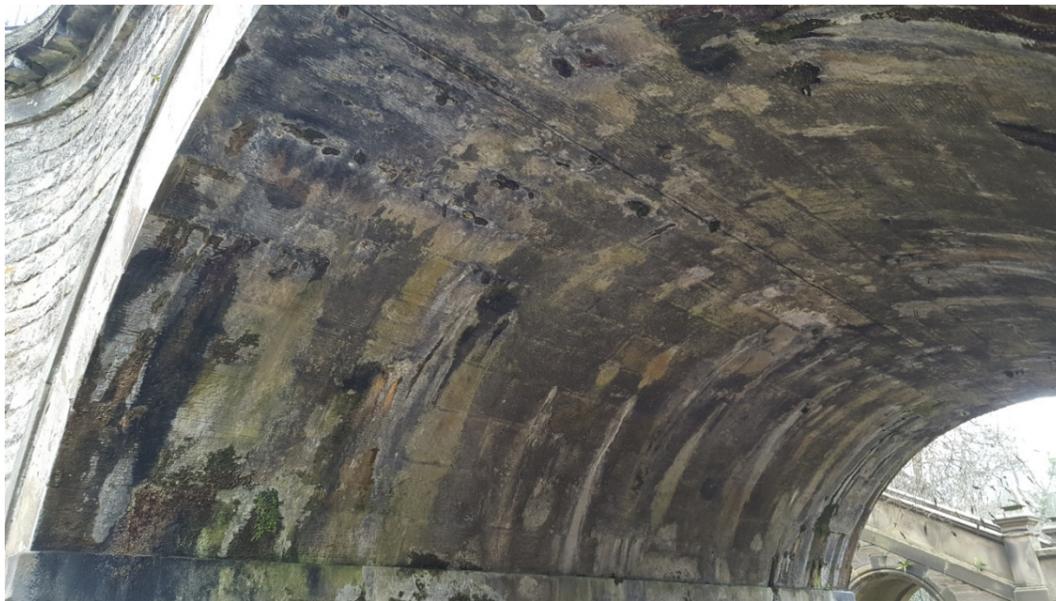
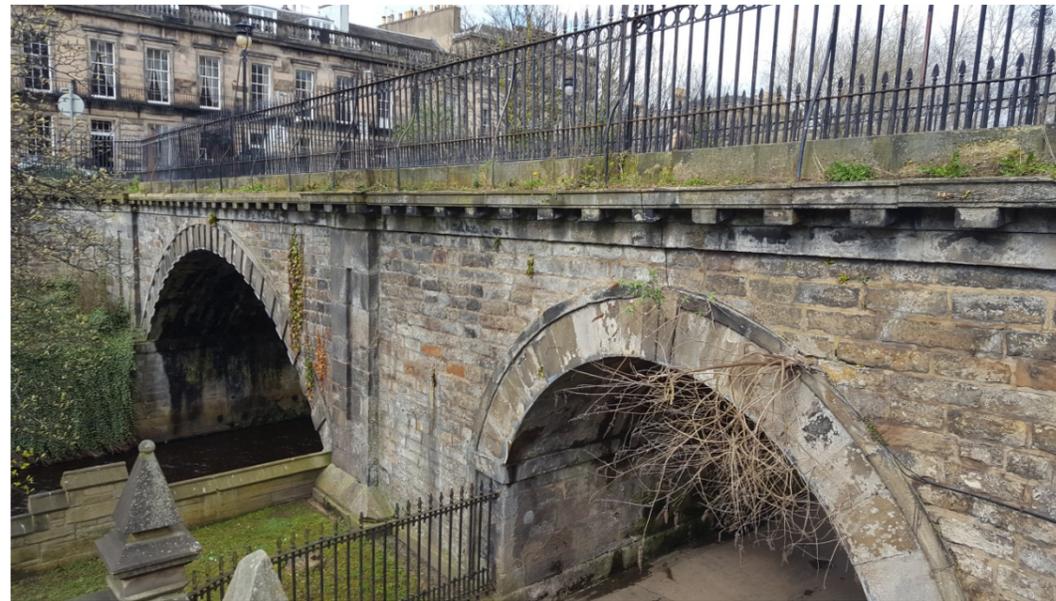
4.18 There is some salt leaching and staining evident on the soffit of the main vault along with some open joints. The salt migration suggests the waterproofing of the main bridge roadway and footpaths may be breached and should be checked and repaired.

4.19 There is some vegetation growing out of the spandrel panels on both sides of the bridge, and old roots have not been removed entirely from the masonry above the voussoirs on the south side of the bridge.

4.16-4.21	St Bernard's Bridge	Salt leaching and staining evident on the soffit of the main vault along with some open joints.	Waterproofing of the main bridge roadway and footpaths may be breached and should be checked and repaired.	<b>Desirable</b>	Further investigation required

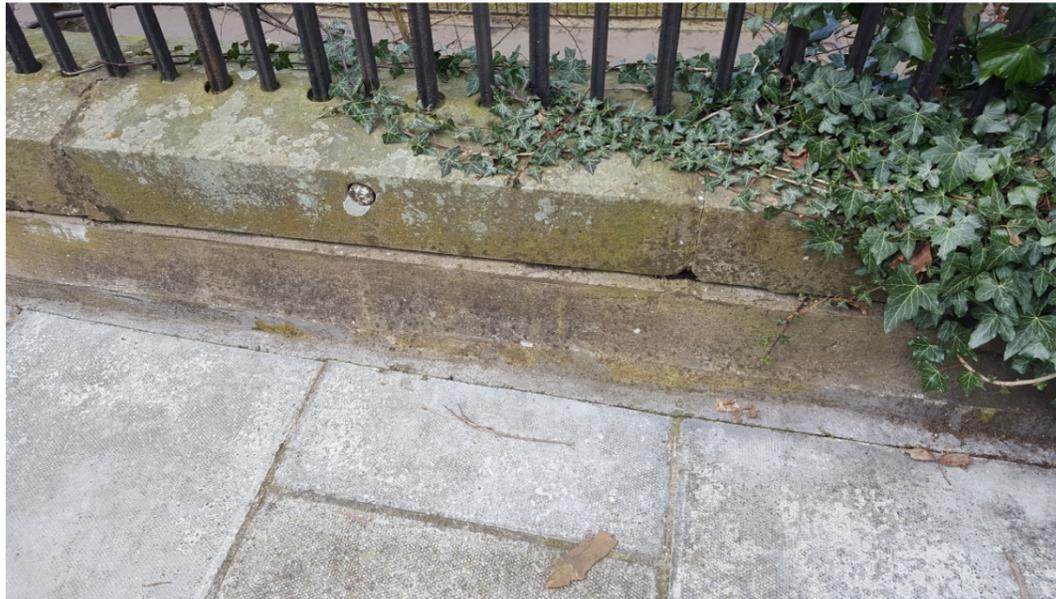
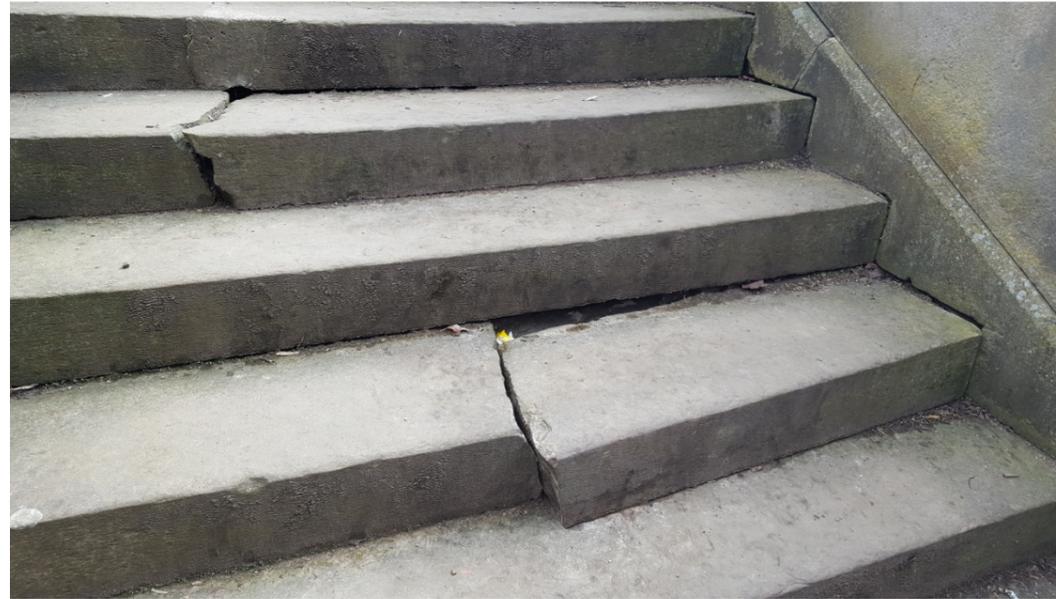
4.20 There was some movement evident in the cope stones of the parapet which should be re-set as part of future maintenance. The stairs on the south-west side of the bridge has two steps which are in very poor condition and should be replaced or repaired and re-set to remove trip hazards. The walls associated with these steps are also demonstrating signs of movement and distress, and require partial duntaking and rebuilding.

Reference:	Structure:	Defect:	Repair Recommendation:	Urgency Assessment:	Order of Cost
4.16-4.21	St Bernard's Bridge	Stairs on the south-west side of the bridge has two steps which are in very poor condition	Replaced or repair and re-set	Immediate	£3000

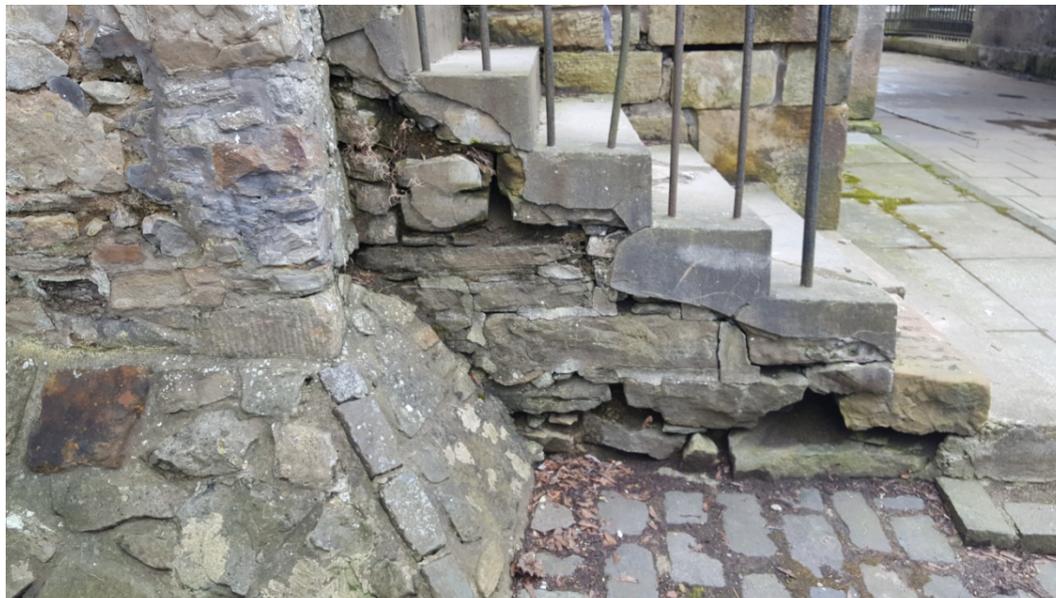
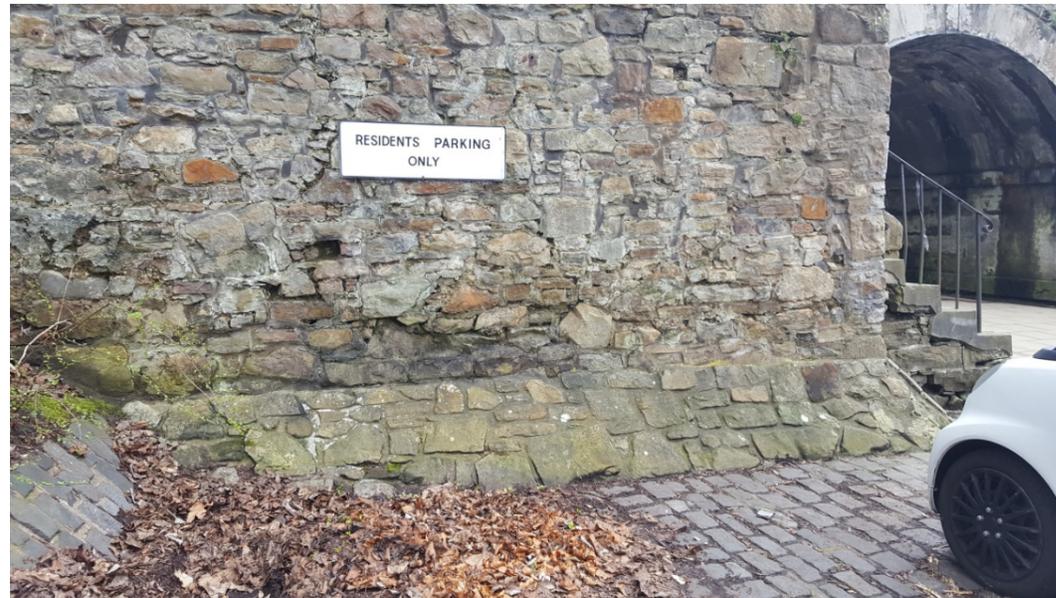
4.21 The parapet balustrade to the south-east stairs needs to be fully repointed as there are open joints throughout and some signs of misalignment:

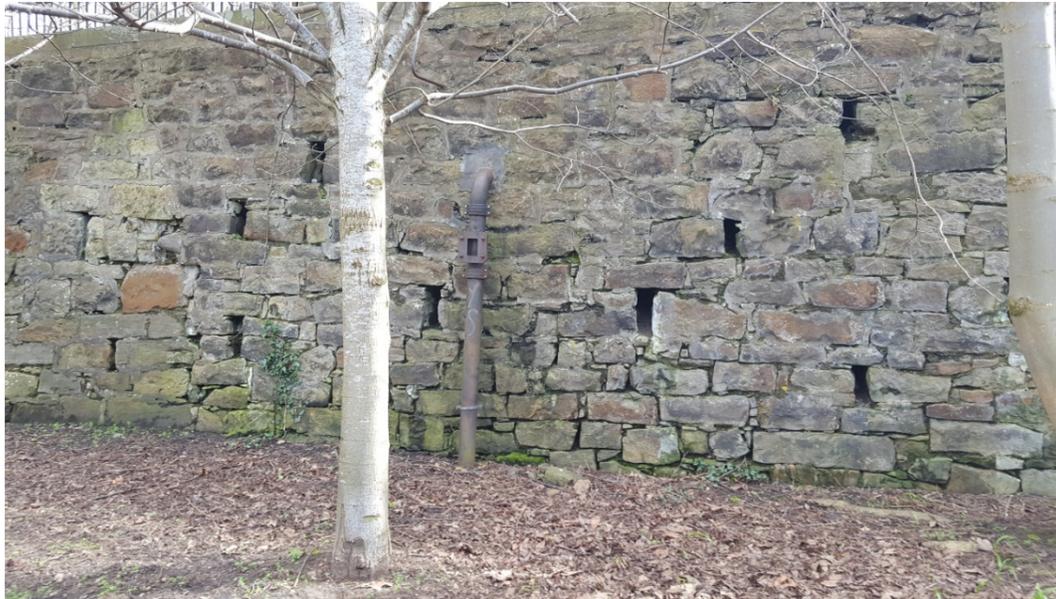
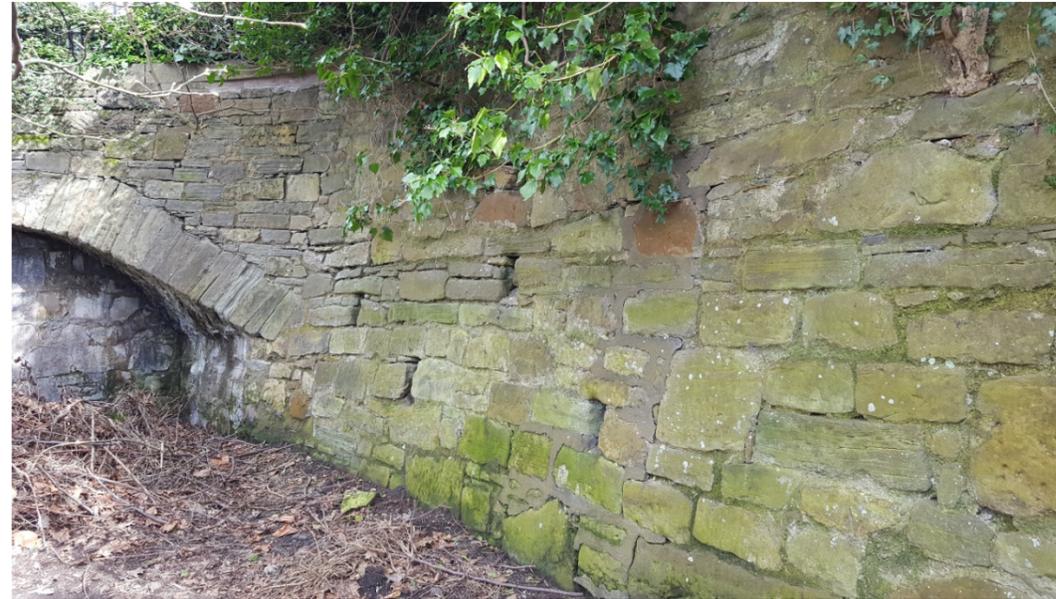
- 4.22 The wall retains the India Place road and pavement to the south-west of St Bernard's Bridge, and is set back from the main Water of Leith footpath. This wall is generally in reasonable condition given its age and likelihood of limited maintenance in the past.
- 4.23 There are a number of locations where there are open joints and small openings in the masonry (which may be old weepholes) which may need some attention. There was no obvious signs of movement or distortion in the wall, or signs of leaning, bulging or distress:

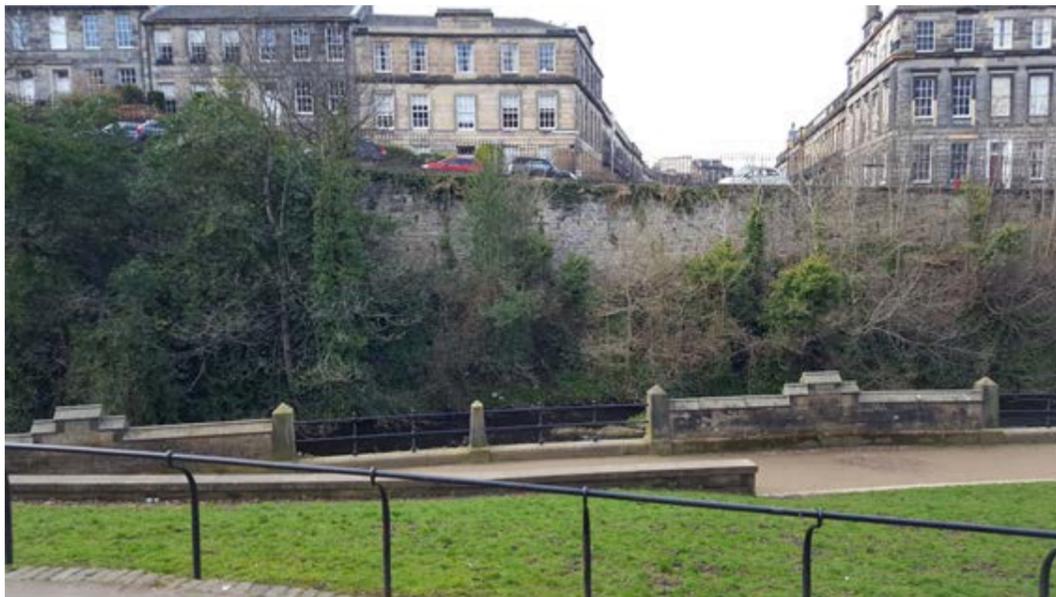
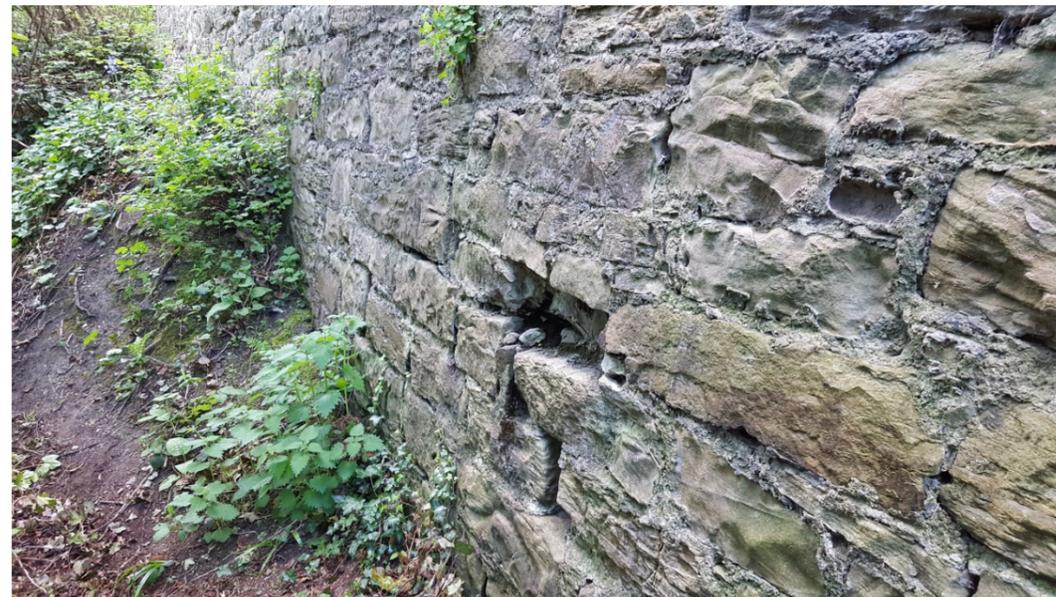
- 4.24 This wall is a massive retaining structure which appeared to be in good condition generally, given its age and probable past maintenance programme. Ivy has been cleared from the wall and some repairs carried out a few years ago.

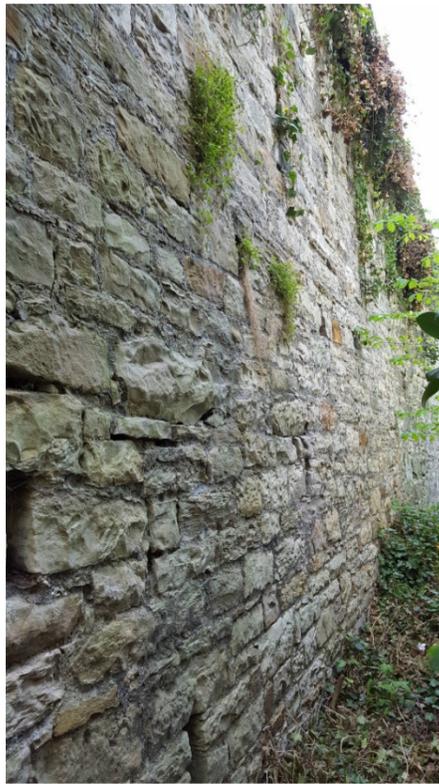
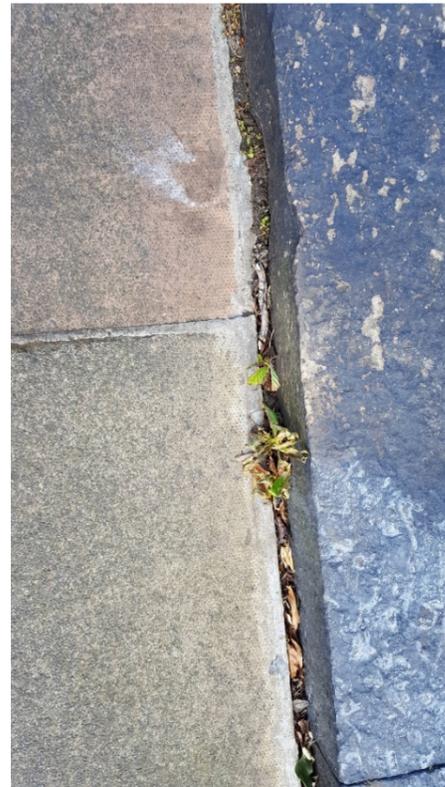
4.25 There is some bulging evident in the middle section of wall but this has not resulted in cracking of the masonry. There is evidence of some movement of the wall and settlement of the footpath sub-base, along with some separation between railing coping stones and footpath. It is probable that the wall is not a solid structure but made of arches spanning parallel to the road. The apparent movement should be investigated further by trial pitting or exploratory localised opening-up of the outer stonework.

4.24-4.27	Upper Dean Terrace Wall	Bulging evident in the middle section of wall. Evidence of some movement of the wall and settlement of the footpath sub-base.	Investigate wall construction further at base and below upper footpath. Repair footpath and main wall if necessary	<b>Necessary</b>	Further investigation required

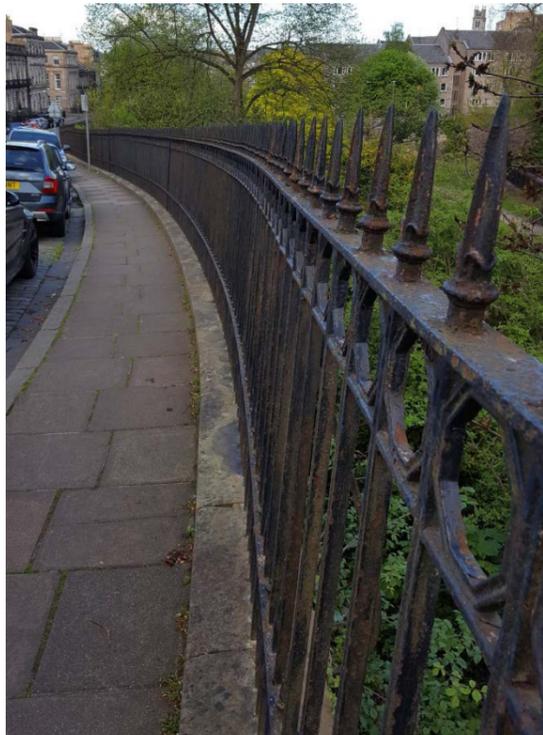
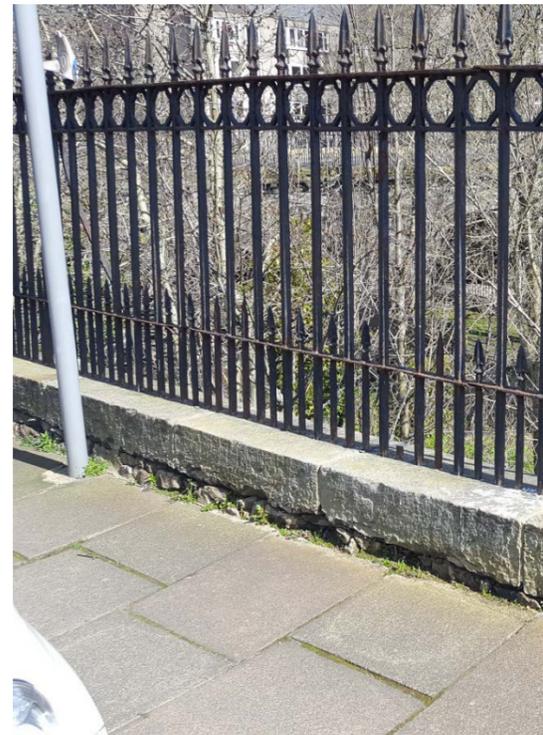
4.26 There has also been some rotation of the main coping stones which is not reflected in the wall below, with most of the wall exhibiting no signs of untoward lean or out-of-plumbness. Some scour and cracking of the masonry below the cope is evident to the east end of the coping nearest the St Bernard's Bridge:

4.24-4.27	Upper Dean Terrace Wall	Rotation of the main coping stones and damage to wallhead/ foundations	Re-set copes and associated repairs to wallhead	Urgent	£75,000

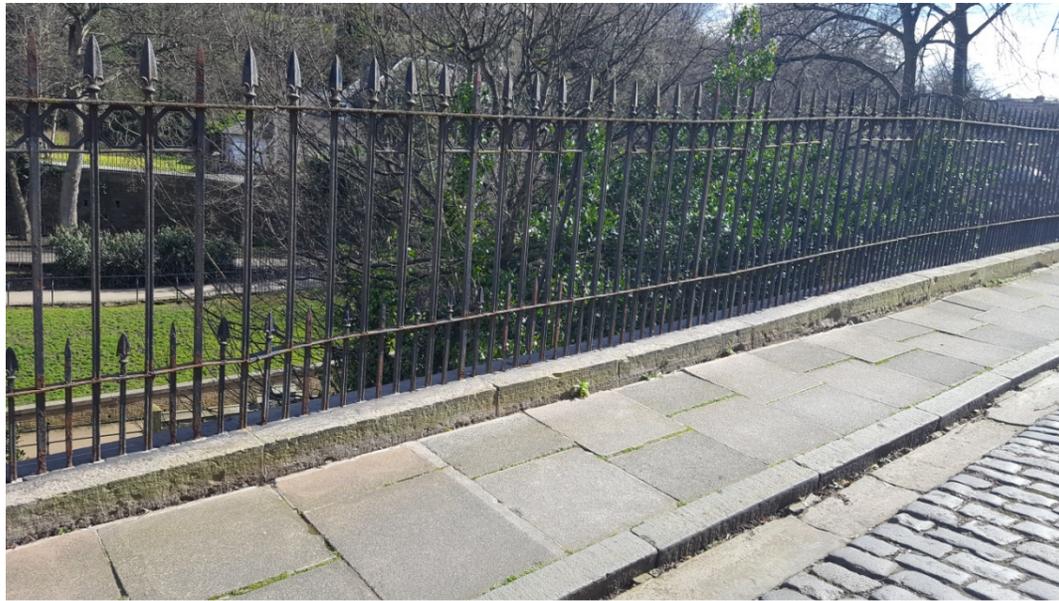
4.27 There is some missing metalwork on the railings which should be repaired to maintain the integrity of the balustrade.

4.24-4.27	Upper Dean Terrace Wall	Missing railing metalwork	Repair railings	Urgent	See railings section
4.35-4.37	Dean Bridge	Failure of waterproofing of the road surface resulting in salt movement and staining of the soffit of the vaults	Repair road and pavement waterproofing and relieve water pressure in fill material	Urgent	Further investigation required

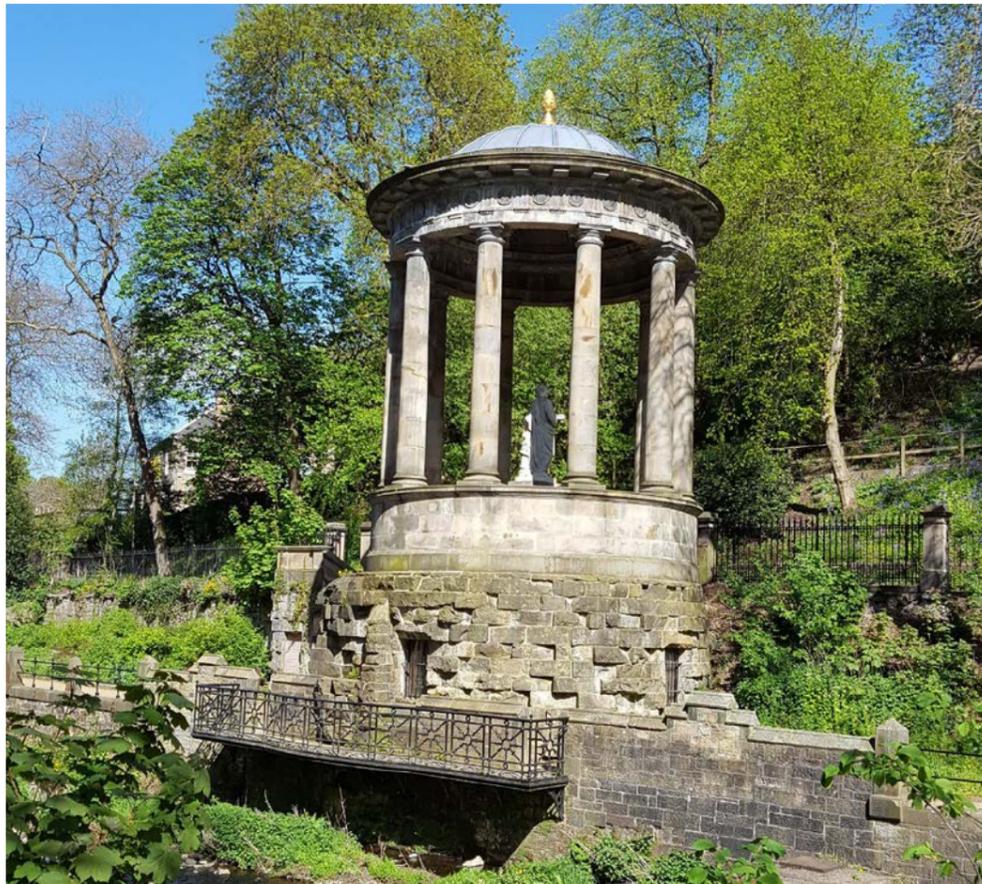
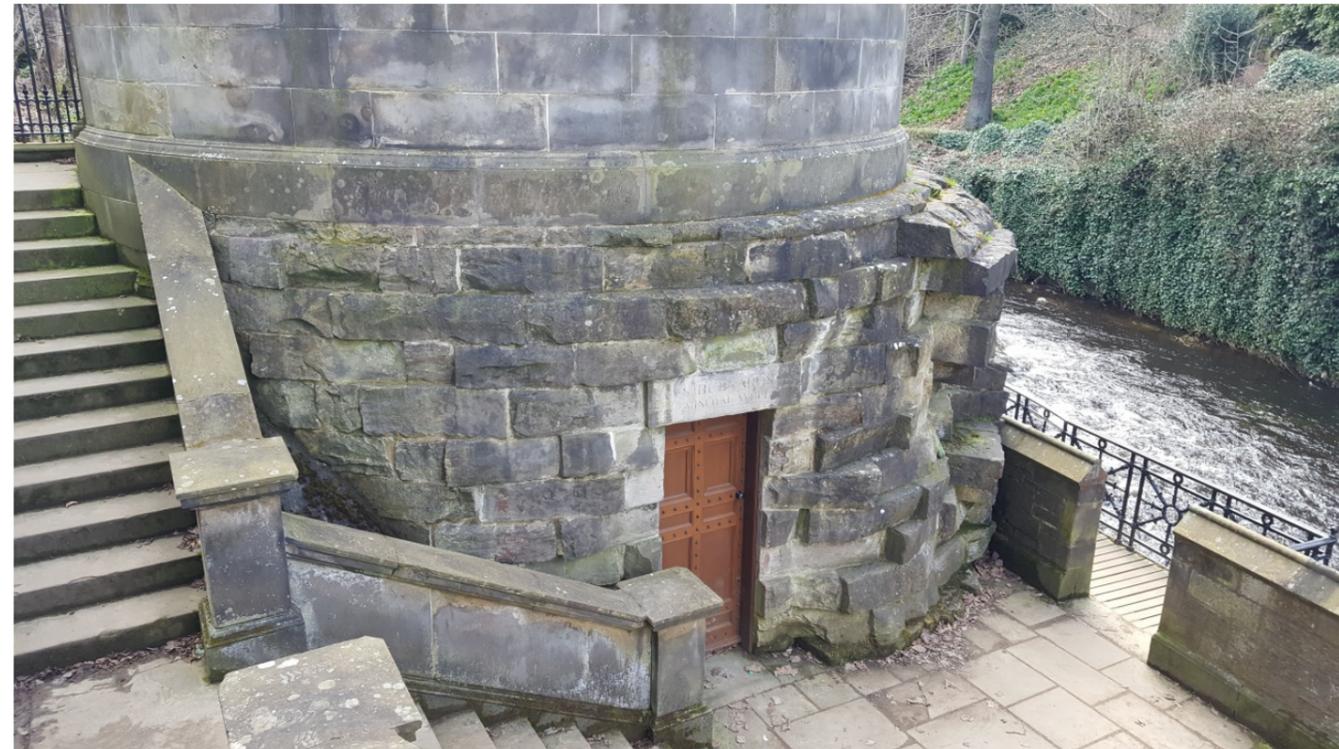
4.29 The small section of walkaway cantilevered on brackets from the main wall appeared to be in good condition, as did the supporting wall below:

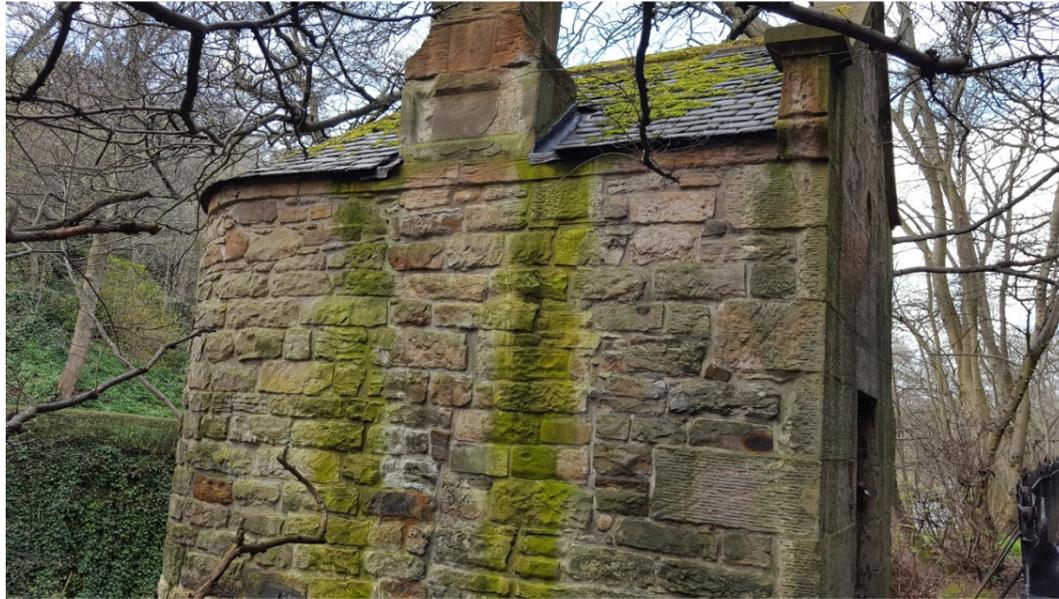
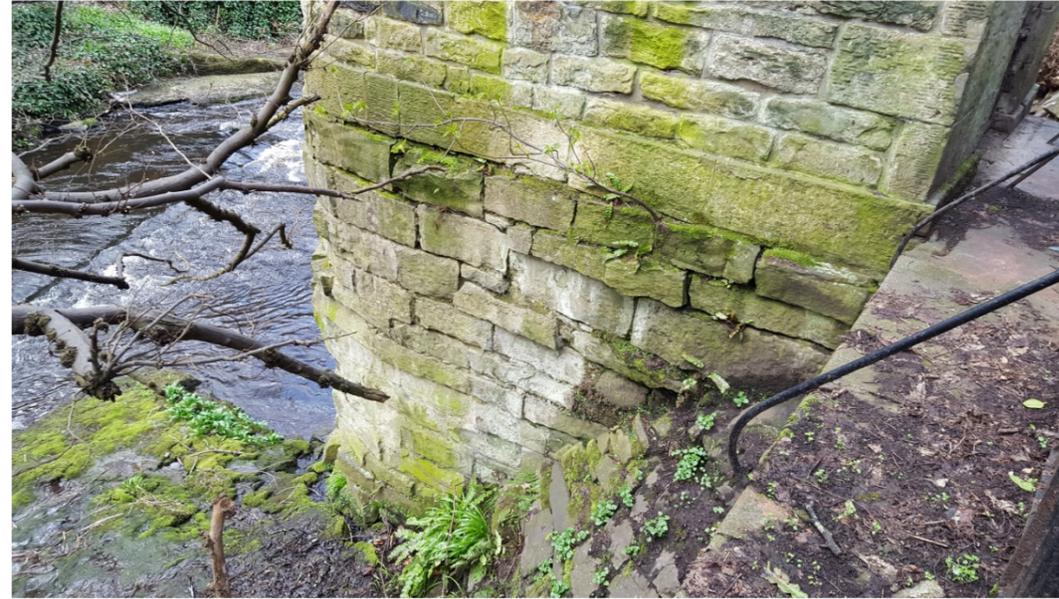
- 4.30 The main building appeared to be in reasonable condition given its age and probable past maintenance programme.
- 4.31 There is some algal growth at eaves level at the overflow drips. The chimney appeared to be in good condition, as did the rest of the masonry apart from some localised open joints. The latter require repointing and where vegetation growth is present; this should be treated with herbicide and removed.
