# DEAN VALLEY REGENERATION

## **Dean Valley Walkway - Second Phase Feasibility Study Report**

Prepared by Land Use Consultants: September 2018

# Dean Valley - Second Phase: Walkway Feasibility Study

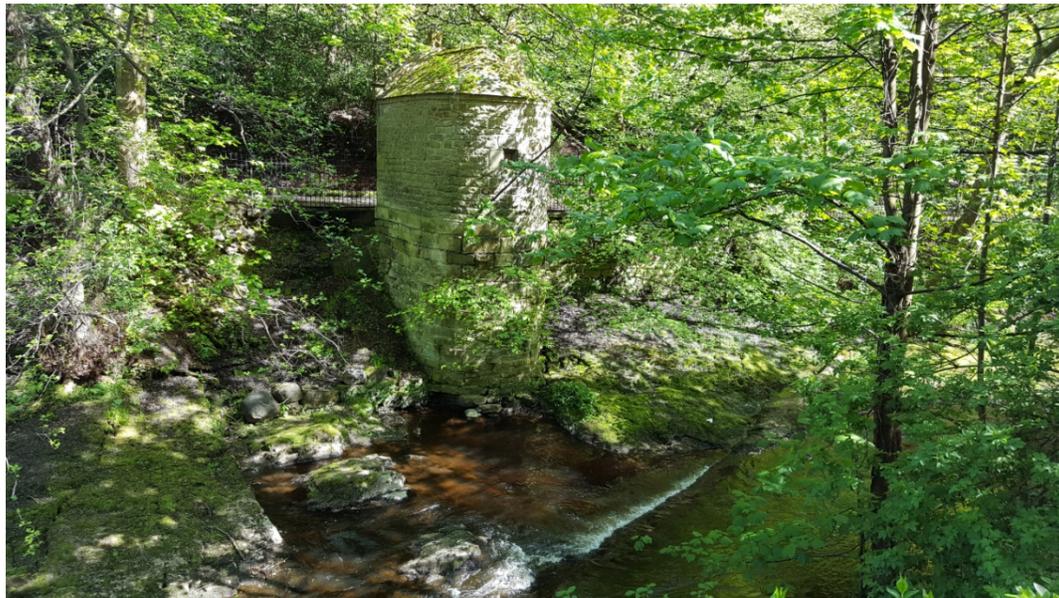
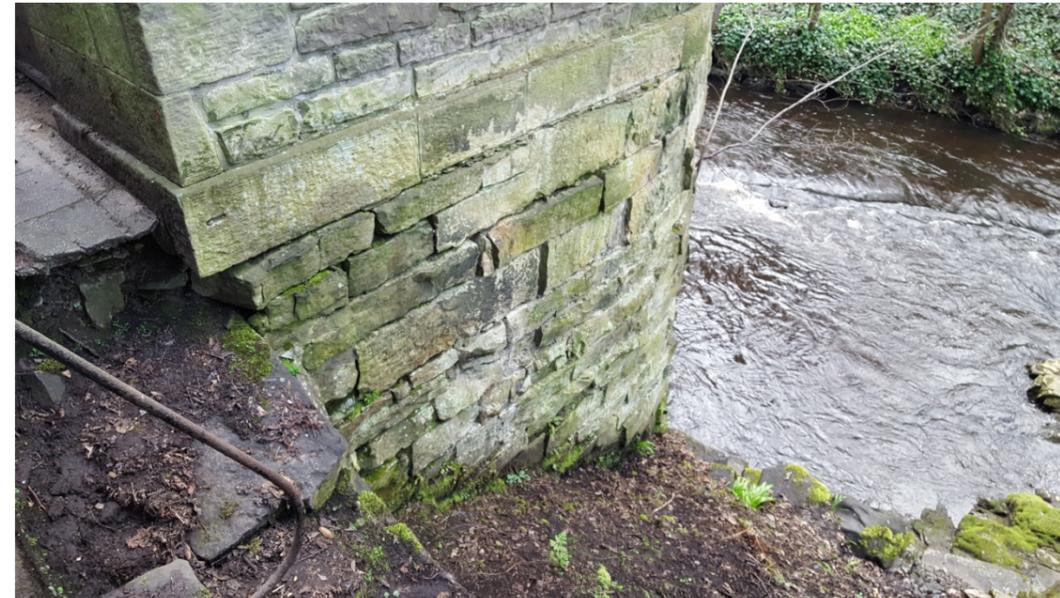
- 4.32 There was some scour evident at the base of the east end of the wall at river level, which may require some localised rebuilding:

4.30-4.31	St George's Well	Scour evident at the base of the east end of the wall at river level	Rebuild or repair wall at low level	<b>Desirable</b>	£2000

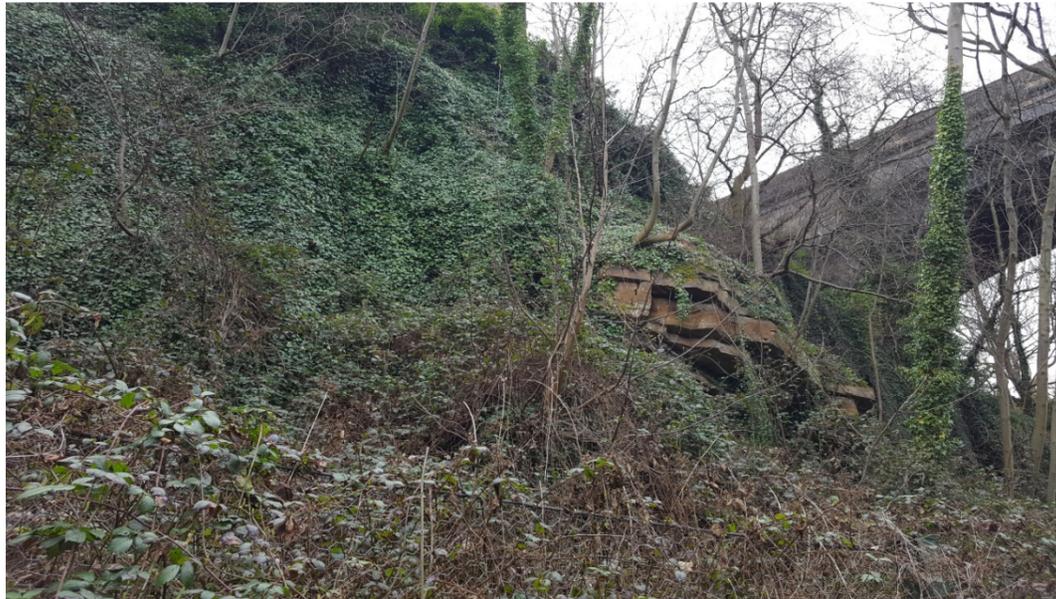
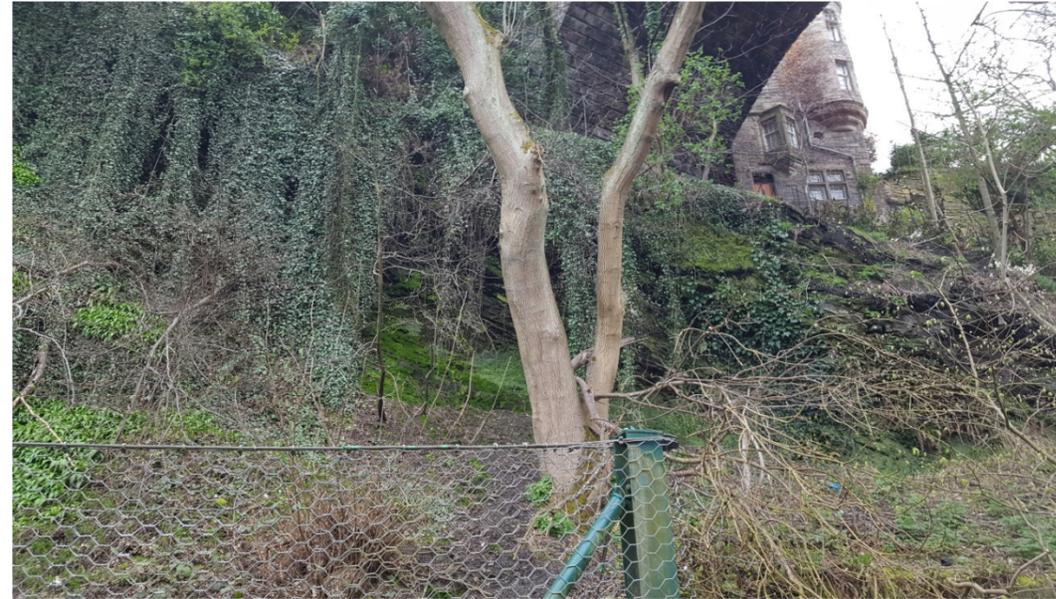
- 4.34 At the base of Randolph Cliff the boundary wall to the walkway becomes low and discontinuous. This allows illicit access into the cliff area below the bridge with associated health & safety risks. Consideration should be given to increasing the height of the boundary wall in this location, and to extending the wall to close the existing gaps. These measures would prevent access from the walkway to the cliff area.

4.33-4.34	Randolph Cliff	Potential risk of damage to cliff from tree growth ; access to cliff face from the walkway	Removal of trees growing from the cliff face ; extension and increase height of walkway boundary wall to prevent illicit access on to cliff face area	<b>Necessary</b>	£15,000

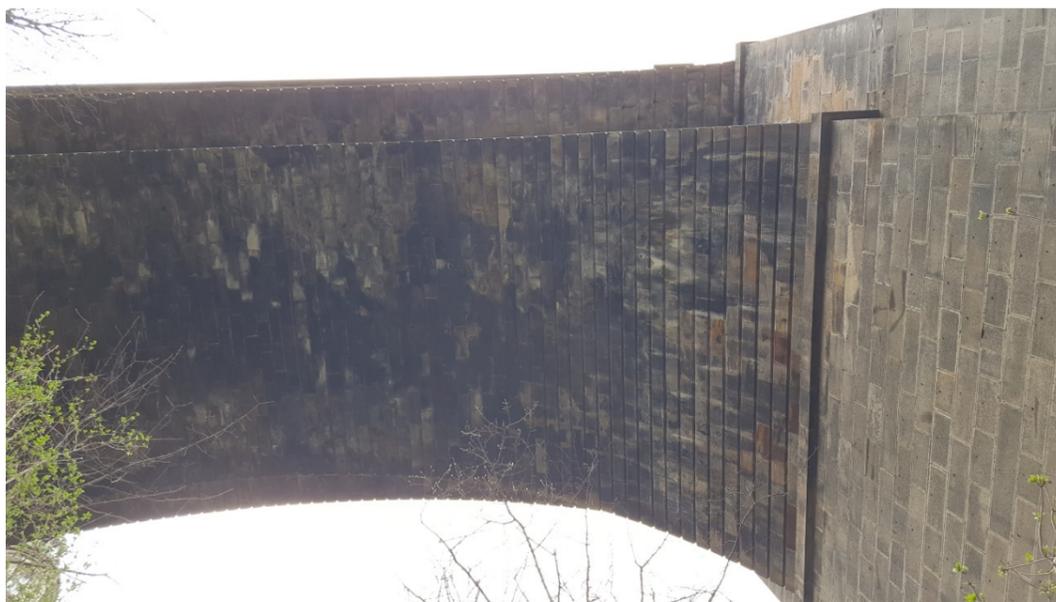
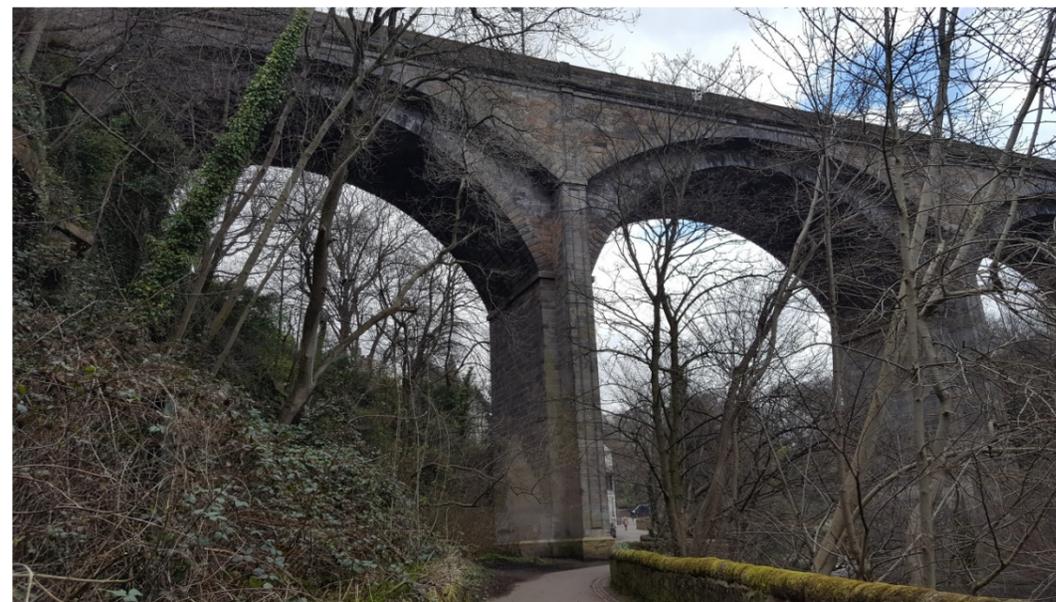
- 4.35 This road bridge is a multi-span stone arched bridge built by Thomas Telford between 1829-31. The main structure is a magnificent example of a well-constructed stone bridge which has been used continuously since its construction. The council roads department is currently responsible for its maintenance which would mainly consist of standard repairs to the main carriageway, footpaths and parapets. The main structure appeared to be in very good condition with no signs of structural movement or deflection and no signs of stone deterioration on the main piers or soffits of the arches.

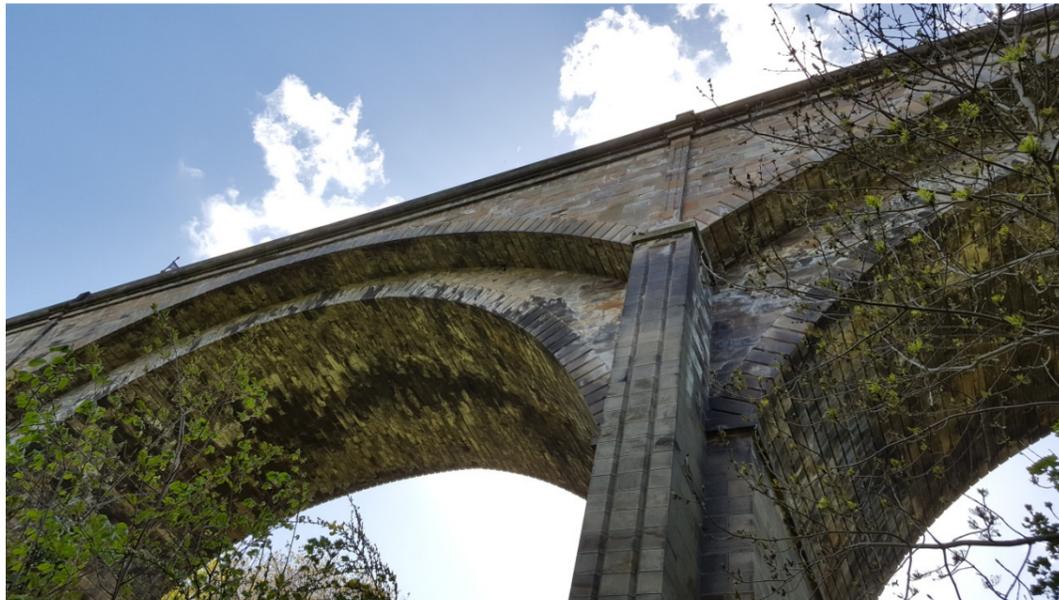
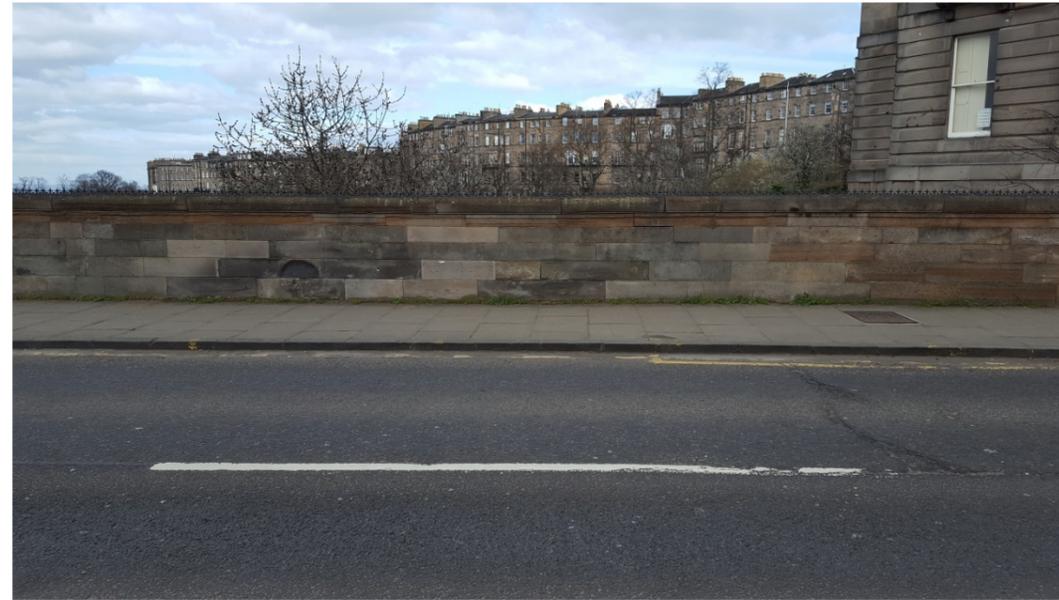
- 4.36 There was evidence of failure of waterproofing of the road surface resulting in salt movement and staining of the soffit of the vaults. Trapped water may not have a route out of the spandrel fill material and some investigation into the previous maintenance actions carried out should be made to confirm whether the incorrect use of cement repointing has been carried out at some point in the past, thereby restricting water egress.
- 4.37 The parapets appeared to be in very good condition along with the footpaths on each side of the road, with only minor surface damage to some isolated stones. The main structural lines of the bridge appeared true and aligned and there was no apparent movement of the voussoirs, soffit, abutments or the top surface.

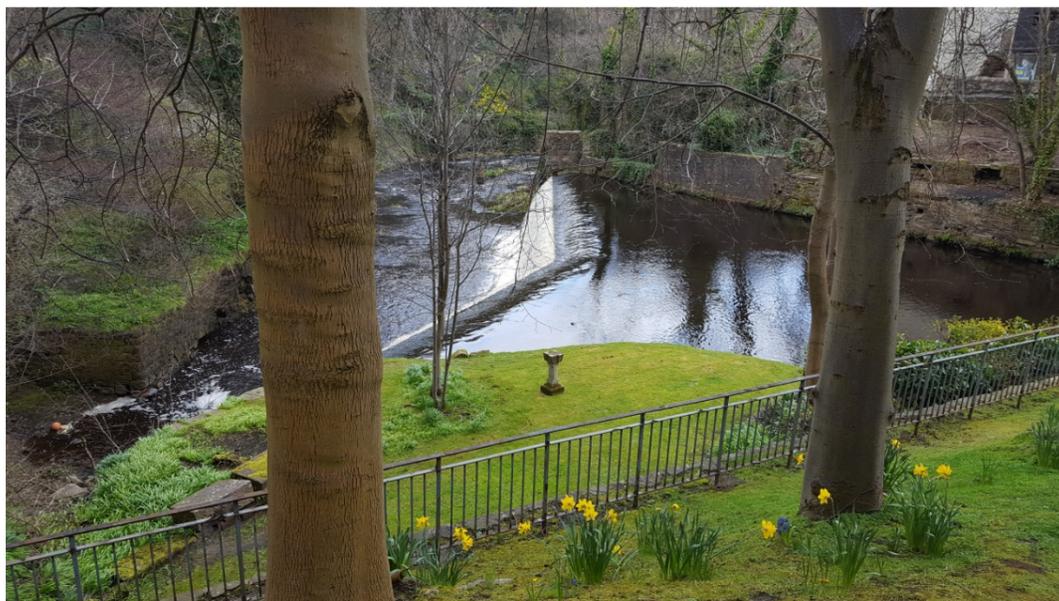
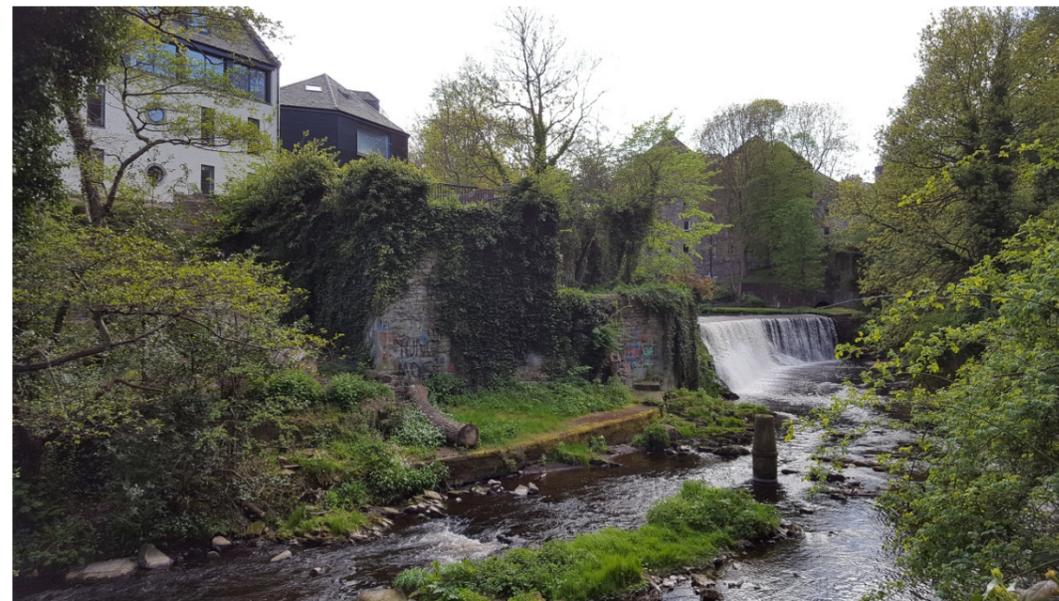
- 4.38 This structure was observed from three different vantage points (from the north-east in Dean Gardens, from the west from a garden at the end of West Mill Lane, and from the seating area off Miller Row), and in each case the weir was obscured by the water flowing over the top of the structure. No means of assessing the weir structure directly was found, but the water appeared to be flowing over the top in a uniform depth and line, suggesting the structure below is correspondingly uniform.
- 4.39 Further investigation would only be possible by limiting the water flow over the weir in sections. The Flood Prevention Department at the City of Edinburgh Council should have records of the weir structure, including condition reports. DNA contacted the department and were told that the records would be difficult to access.

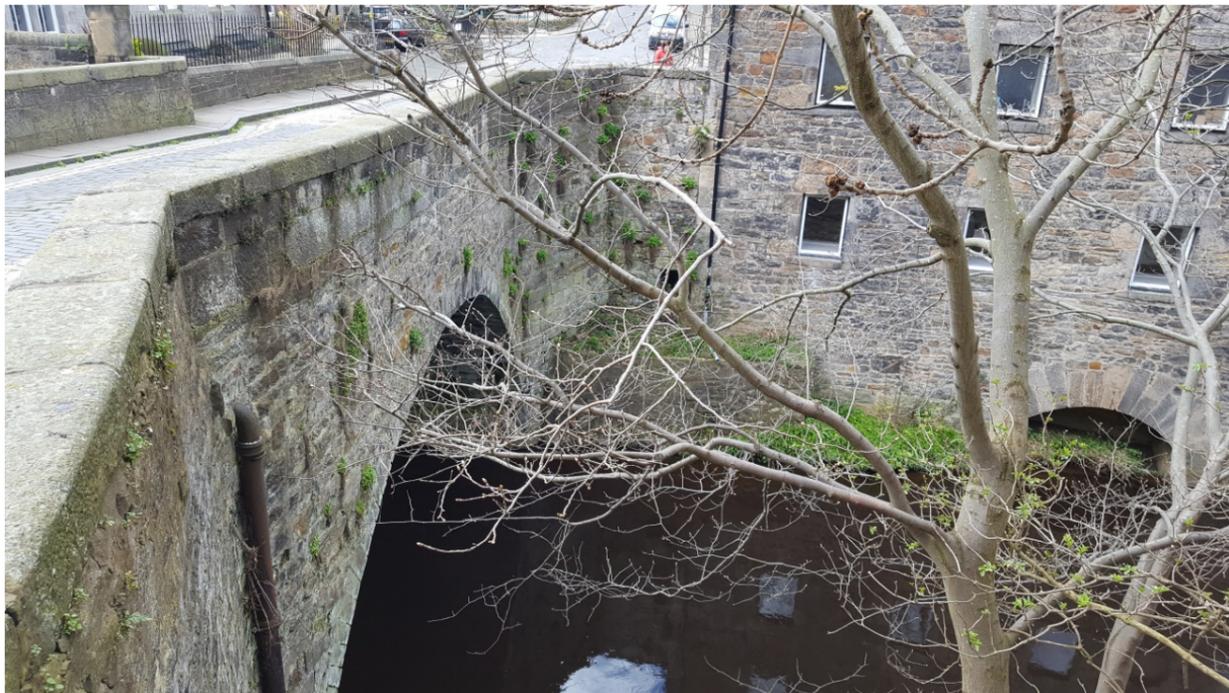
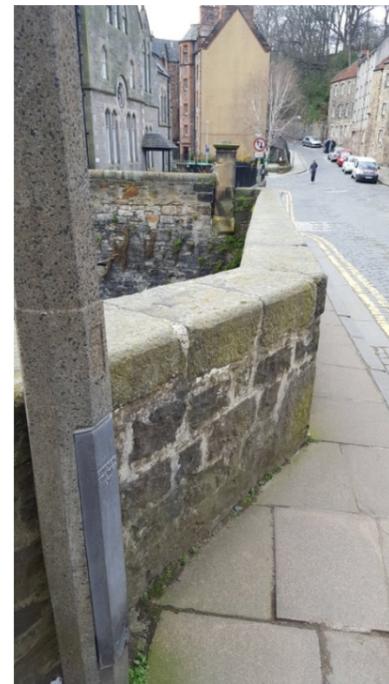
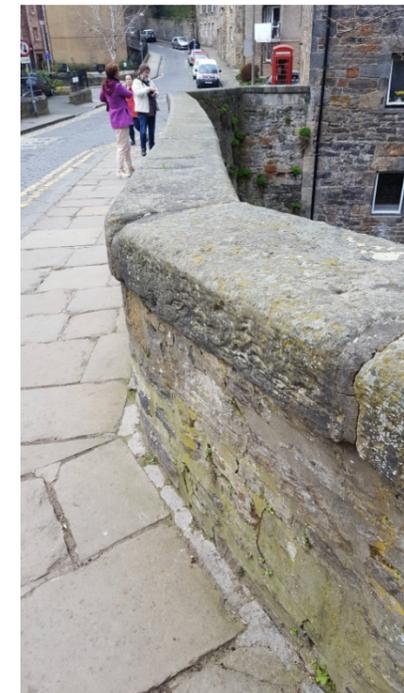
- 4.42 This road bridge is a single span stone arched bridge which has presumably been maintained by the council roads department over time. The main structure appeared to be in good condition with no signs of structural movement or deflection. The parapets on both sides of the bridge appeared to lean outwards but this does not cause undue structural concern. There was no apparent movement of the voussoirs, soffit, abutments or the top road surface.

4.42-4.43	Water of Leith Bridge	Parapets on both sides of the bridge appeared to lean outwards. Detailed investigations needed to determine the cause and necessity for repairs	Re-set masonry or pin parapets subject to feasibility	<b>Desirable</b>	Further investigation required

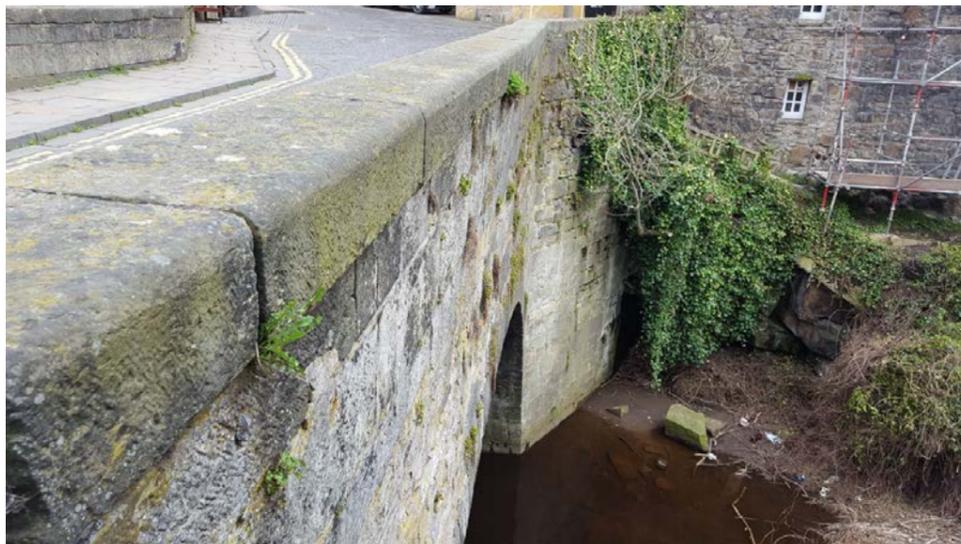
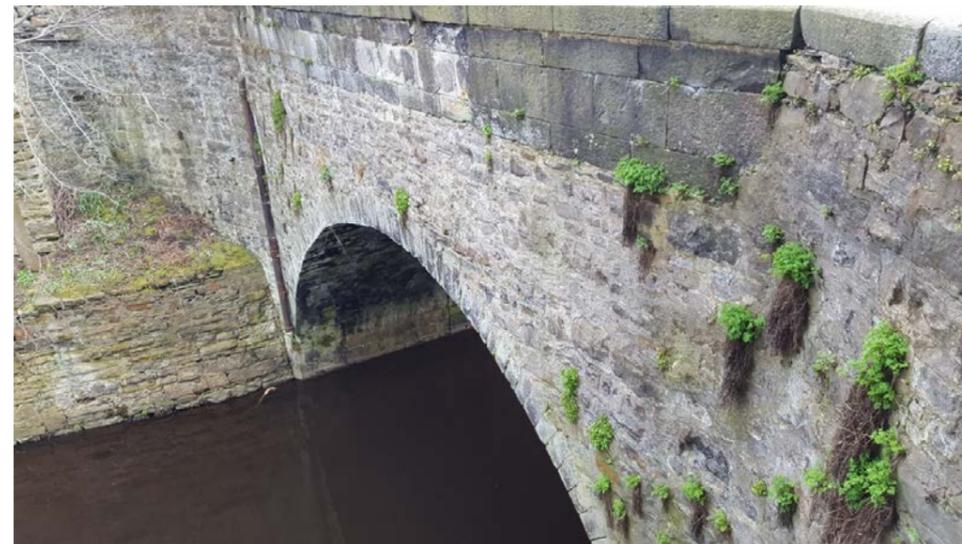
- 4.43 Vegetation growth is apparent in some joints which should be chased out as part of normal maintenance. The vegetation appears to be growing around the spandrel panel which might indicate the fill is wet and providing a continuous source of water:

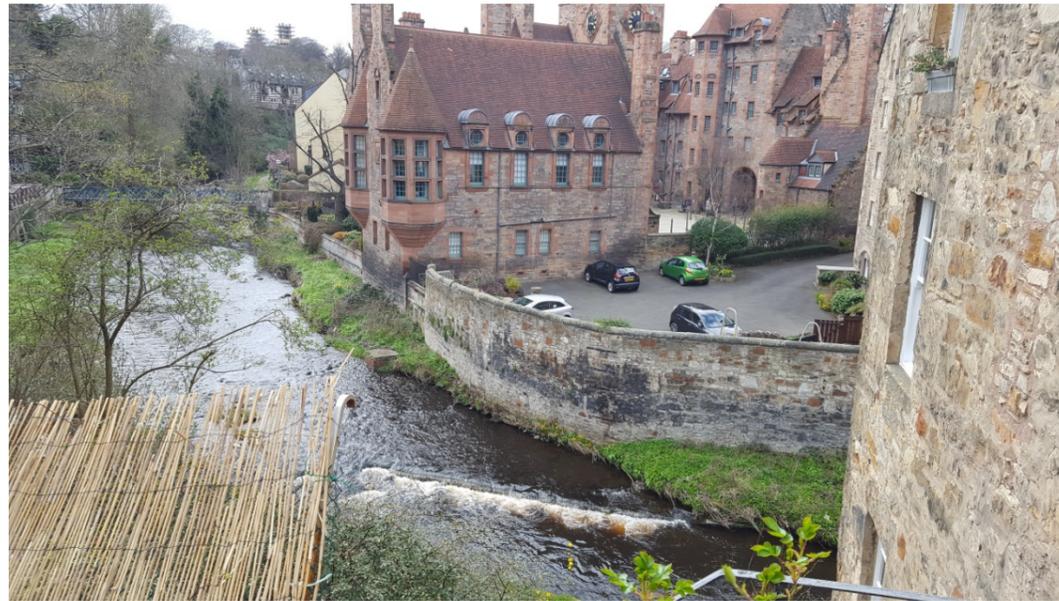
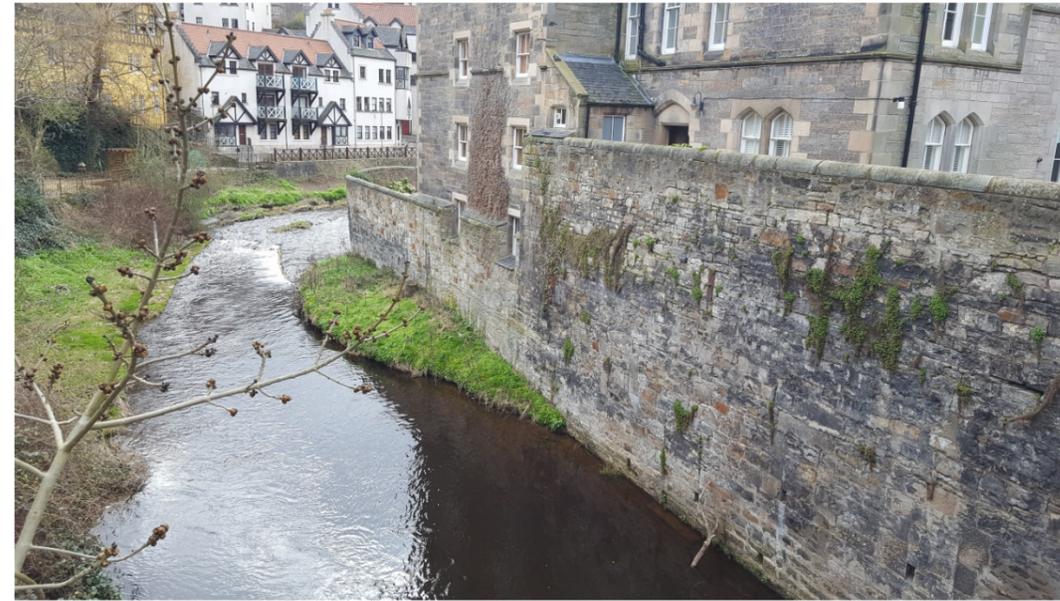
- 4.44 There was limited opportunity to view the wall in detail but DNA can confirm that the wall appeared to be intact and generally in good condition, given its age and past maintenance history. The riverside freestanding wall appeared to be leaning outward at the main curve in the river but there was no sign of cracking or distress, suggesting the wall has been maintained with this distortion in the past.

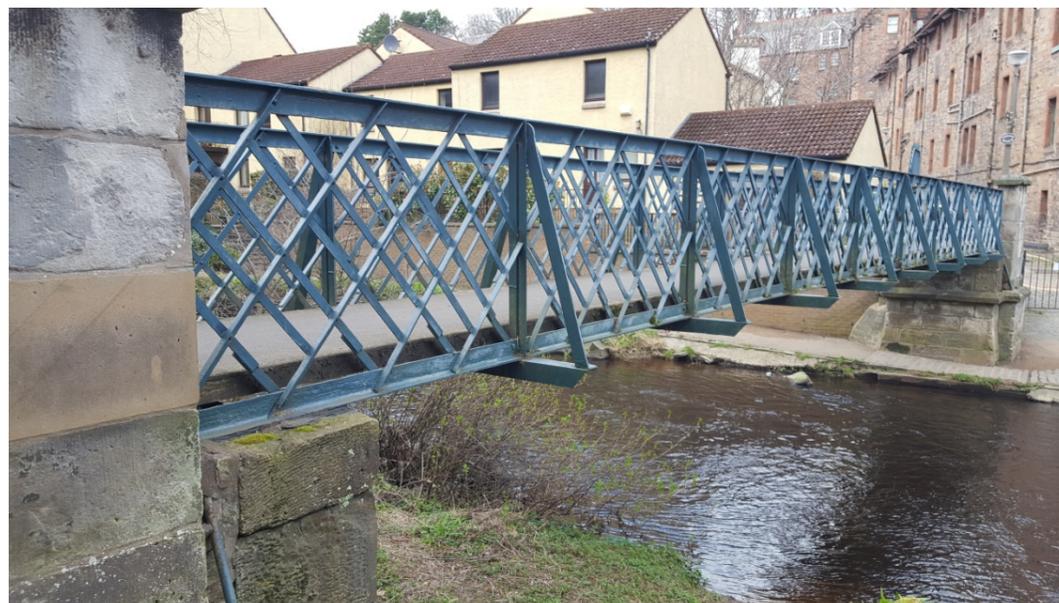
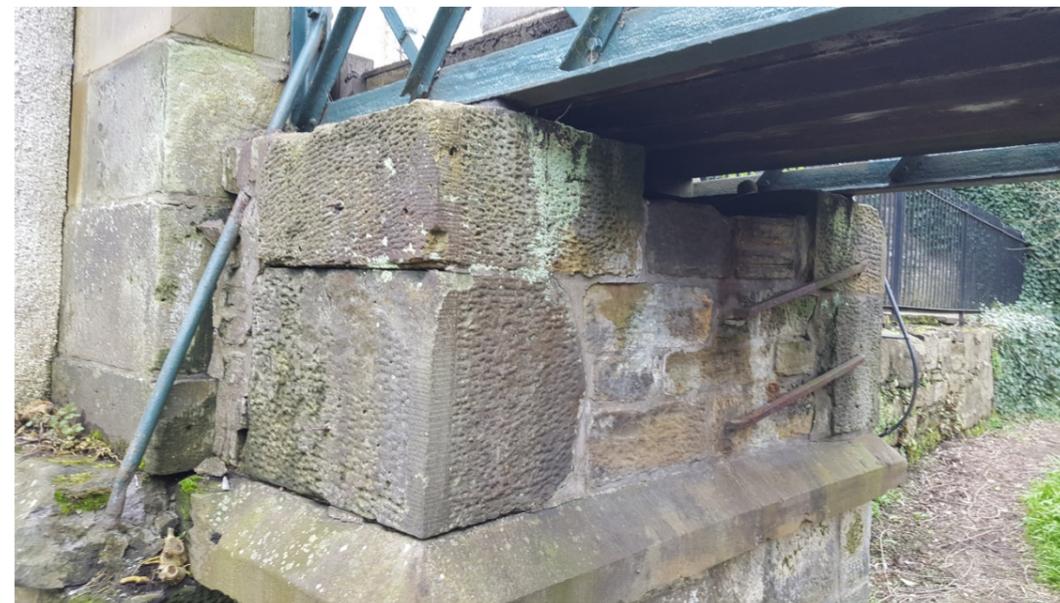
- 4.45 This footbridge is a steel trussed bridge with timber infill boarded floor. The abutments are clad in masonry but are probably reinforced concrete. The abutments appeared to be in good condition with no obvious signs of distress, movement or distortion.

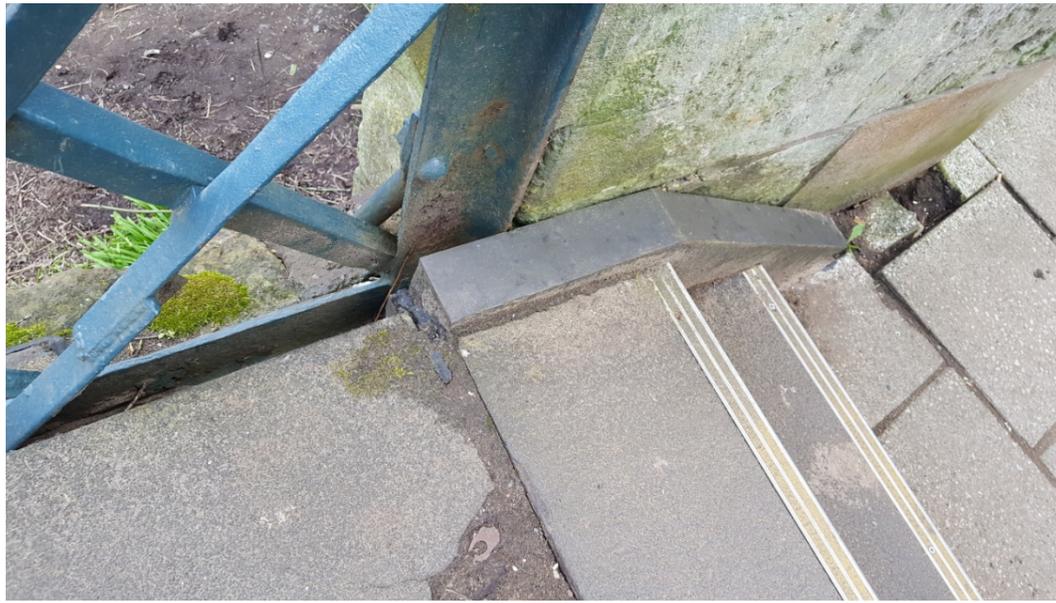
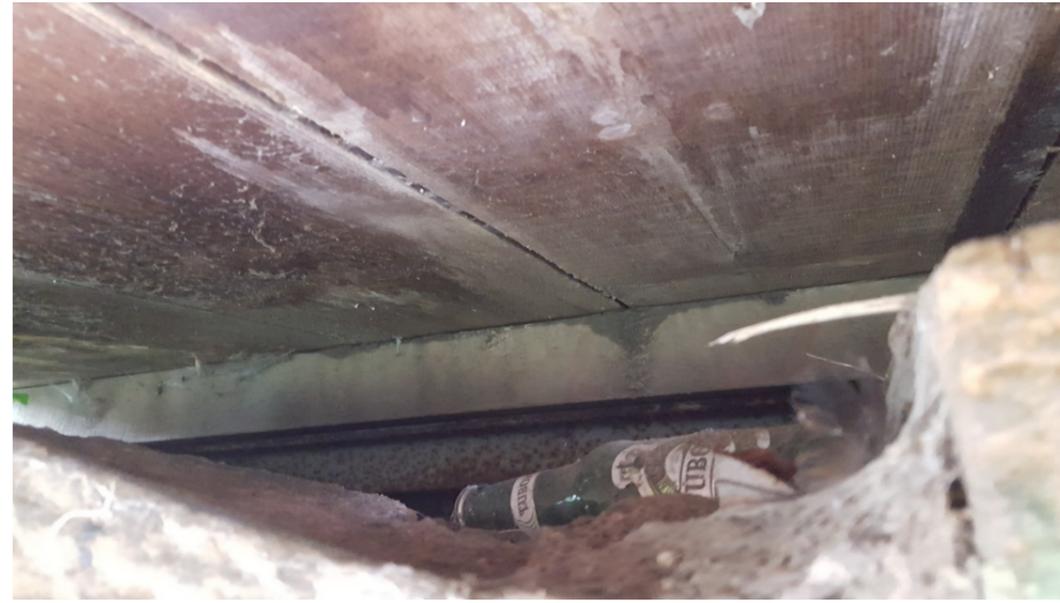
- 4.46 Generally the steel framing was in good condition with intact durability coatings, except for one area at the south-east bearing where the paint coating had broken down and allowed some surface rusting to occur. This area should be wire-brushed back to sound and a rust inhibiting paint applied prior to finishing coat as part of normal maintenance (left image). The main timber deck had water staining marks across the soffit along with some shakes along the timbers, which would be expected for exposed timberwork acting as a flooring deck. There were no obvious signs of rot or decay but this should be checked further at a number of locations to confirm the timber is intact.

4.45-4.46	Dean Footbridge	Corrosion to steelwork above south-east bearing	Wire-brush back to sound and a rust inhibiting paint applied prior to finishing coat	Urgent	£1000

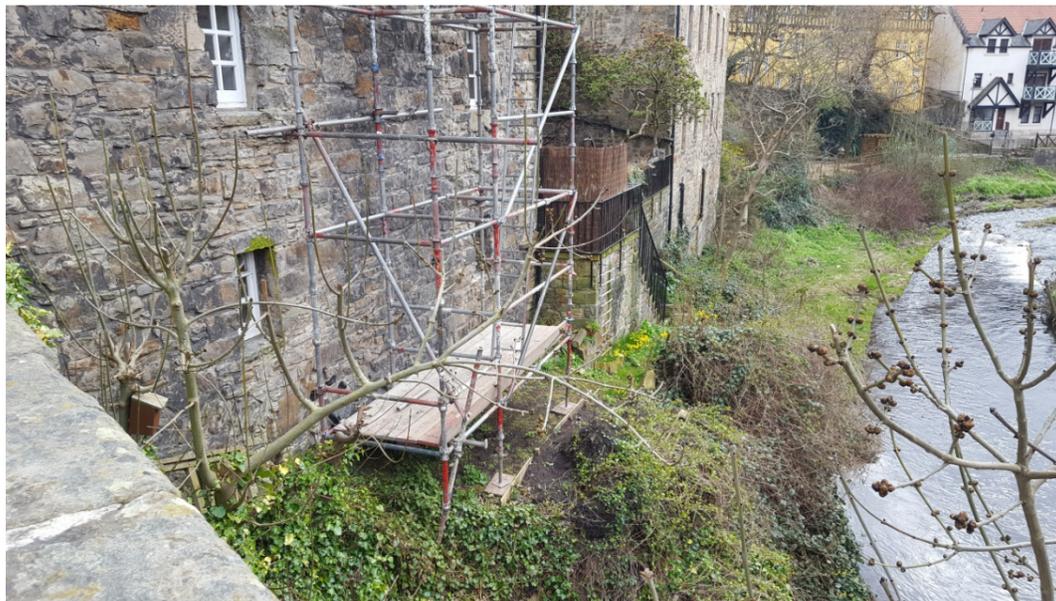
4.47 The walls along this stretch of river are conjoined with the private properties ranged along the riverside, stepping down from the higher level of Hawthornbank Lane (at one or two storeys above street level) to three or four storeys down to riverside. The buildings and walls appeared to have been maintained over time. Although there was limited opportunity to view the wall in detail but DNA can confirm that the wall appeared to be intact and generally in good condition, given its age and past maintenance history.

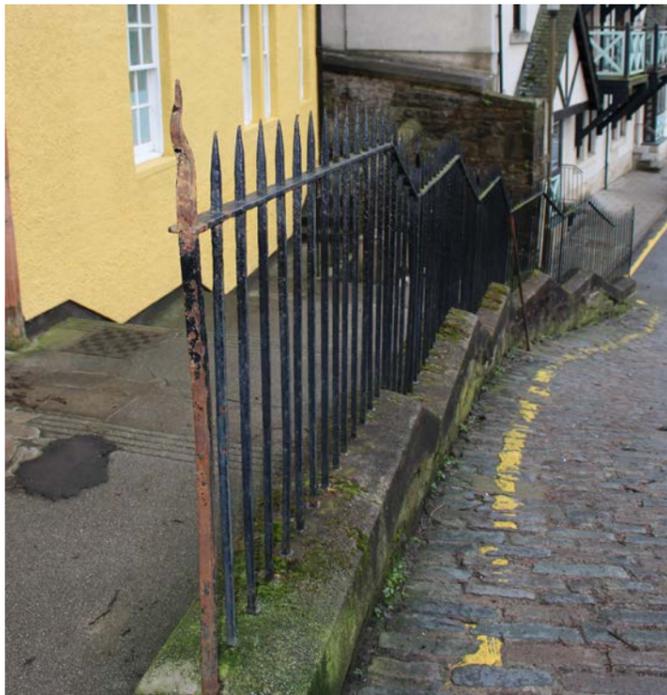
Railings at Hawthornbank Lane

- 5.6 The railings at Hawthornbank Lane are approximately 1.24 m high and made from wrought iron and steel. The railing pattern comprises simple spiked balusters with square section bars and a horizontal top rail. Heavy section end posts with a wrought spiked feature top are also present. These railings surmount a parapet wall adjacent to the lane. They are generally in good condition although need localised repairs and repainting.

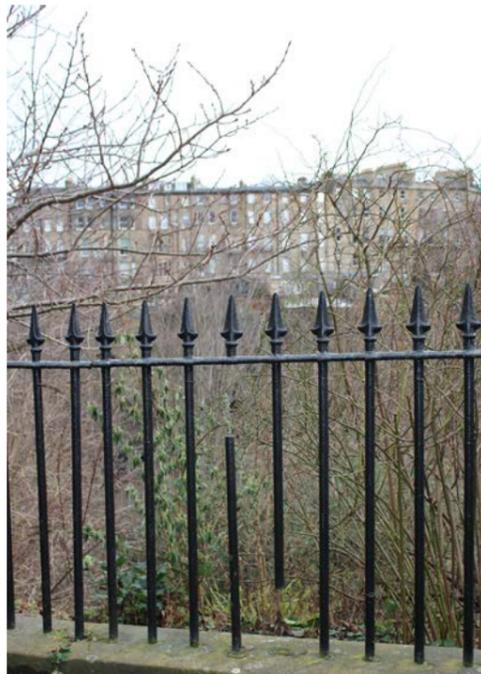
Eton Terrace Railings

- 5.9 Eton Terrace railings are approximately 1.23m high and made from cast iron. The railing pattern comprises heavy round section balusters with spear finials. The railings have an ornamental horizontal top rail which is cast iron and has round bosses where each baluster passes through the rail. These railings are secured into a stone cope which appears to be in good condition and of consistent line and level. The railings have no lower dog rail panel. The gates into the private garden have heavy round posts with 'acorn' pattern finials. The gates have the same spear finials but also have intermediate balusters to prevent access by dogs. The railings are in good condition with some localised repairs needed.

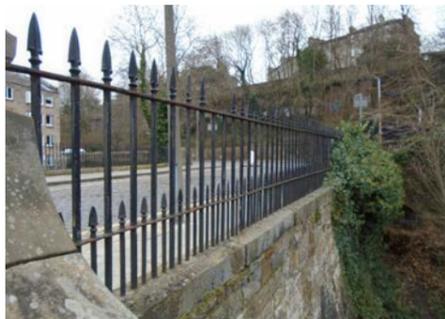
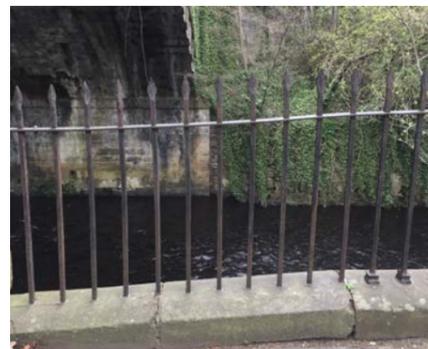
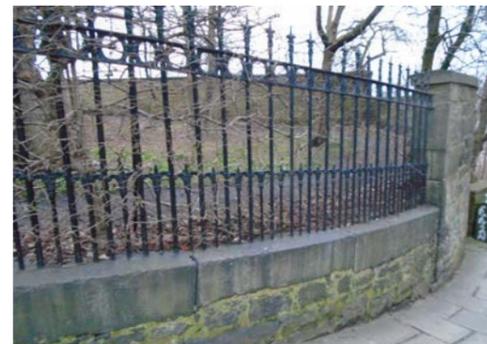
Railings at; St Bernard's Bridge, Saunders Street and Doune Terrace

5.15 The railings along St Bernard's Bridge match those at Dean Terrace; however the octagonal feature is absent. The railings along the bridge are generally in good condition although they need some localised repairs and refurbishment.

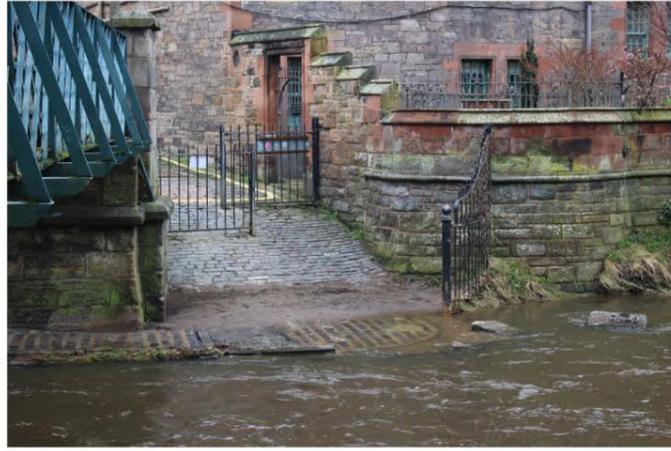
**P4** - Resurfacing to Water of Leith Bridge needed

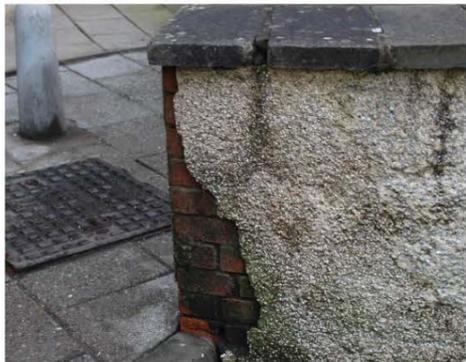
**P1** - Damage to walls and steps at Dean Valley Footbridge

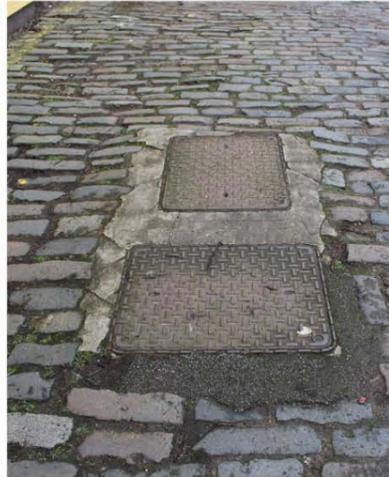
**P3** - Localised repairs/upgrading to surface on Hawthornbank Lane

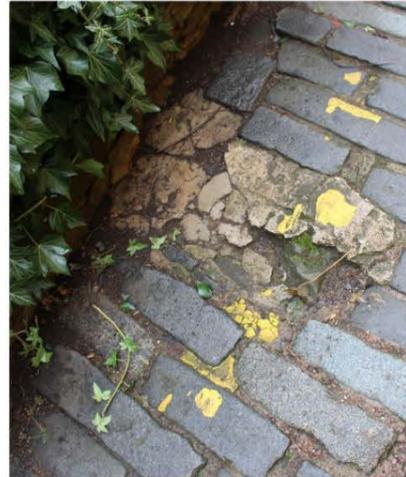
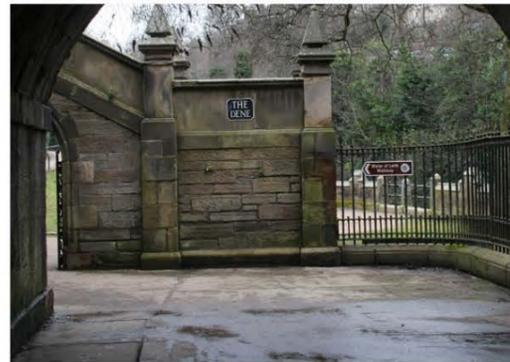
**P5** - 'Entrance' to Dean Valley Walkway from Saunders Street would benefit from upgrade in material surfacing and signage
