# DEAN VALLEY REGENERATION

## **Dean Valley Walkway - Second Phase Feasibility Study Report**

Prepared by Land Use Consultants: September 2018

# Dean Valley - Second Phase: Walkway Feasibility Study

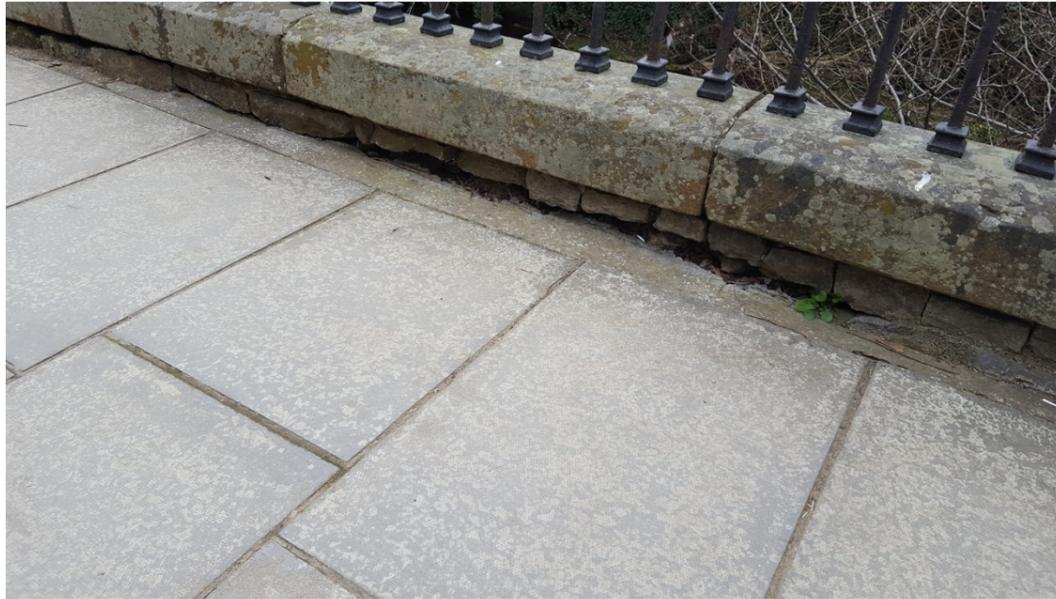
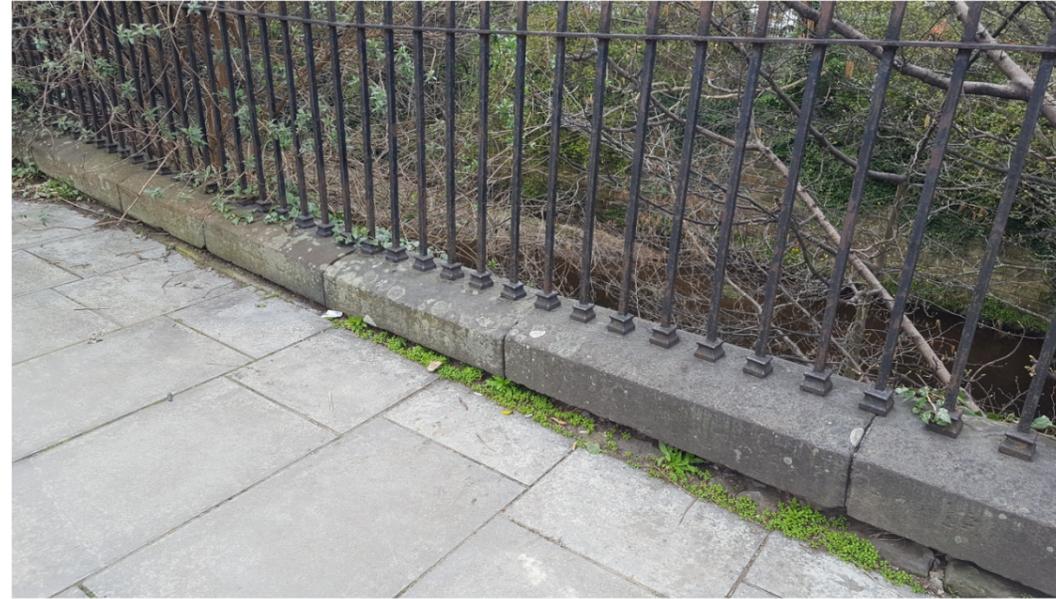
4.11 There is also some scouring and washout of the mortar below the parapet cope stones, which exhibit some movement and voiding of masonry adjacent to the footpath. Betterment of the footpath waterproofing and levels could help limit the requirement for future maintenance, along with rebuilding of the stonework below the copes:

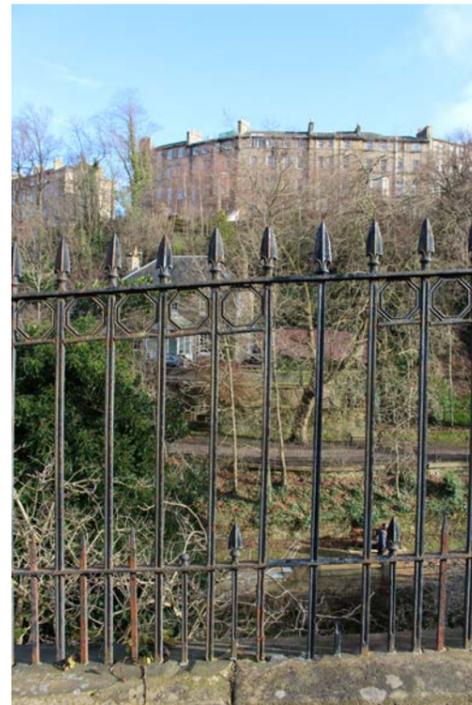
Railings to Upper Dean Terrace and Dean Terrace

3.3 Railings are in need of repair – especially at those at Dean/Upper Dean Terrace

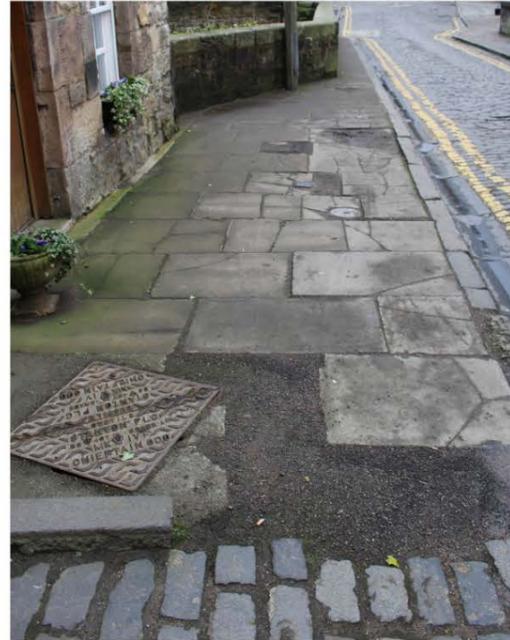
**P4** - Resurfacing to Water of Leith Bridge needed

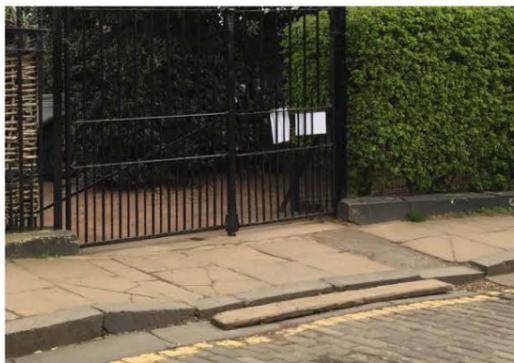
**Left: P6** - Installation of drop and flush kerbs required outside gates to Doune Terrace Gardens

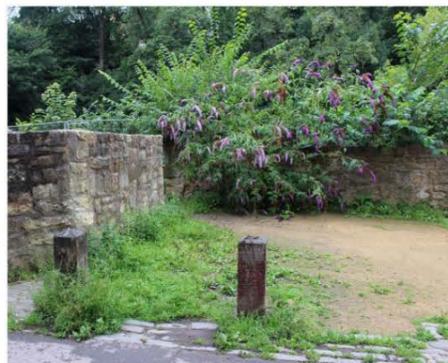
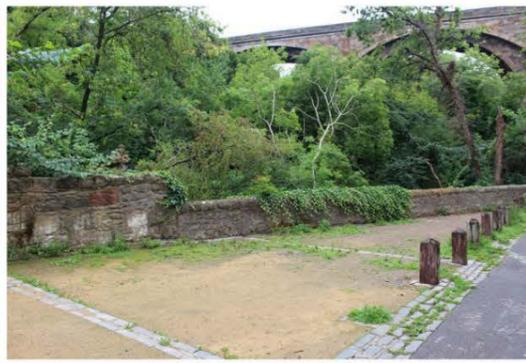
**Left: P7** - Vegetation removal and resurfacing using resin bound or bonded gravel

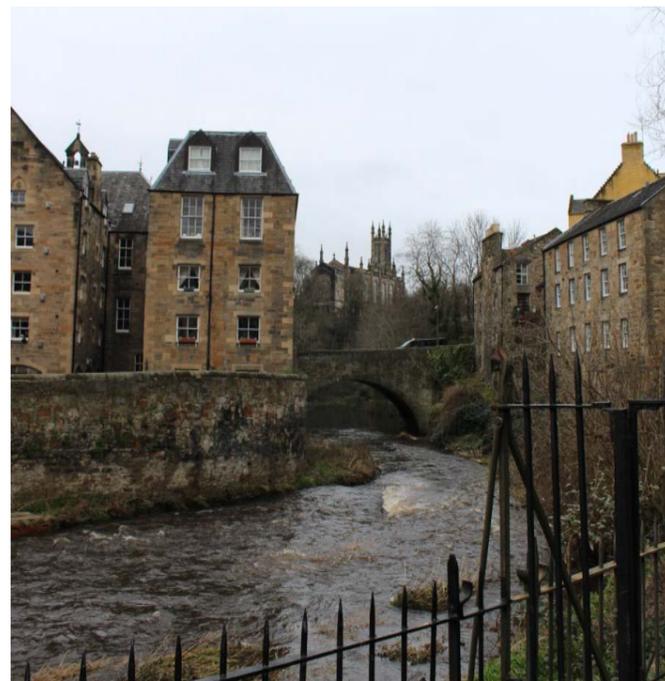
View 2, is partially still visible today, albeit with the addition of some railings in the foreground as shown on the photo. For most of the year the view beyond Water of Leith Bridge, towards Holy Trinity Church will be mostly obscured by the trees and vegetation on the banks of Belgrave Crescent Gardens in the west and the banks of the walkway on the east. Some management and maintenance of the trees along the walkway, pruning them back, would help reinstate View 2 and also View 5.

Figure 3: View 2 - Towards Holy Trinity Church today

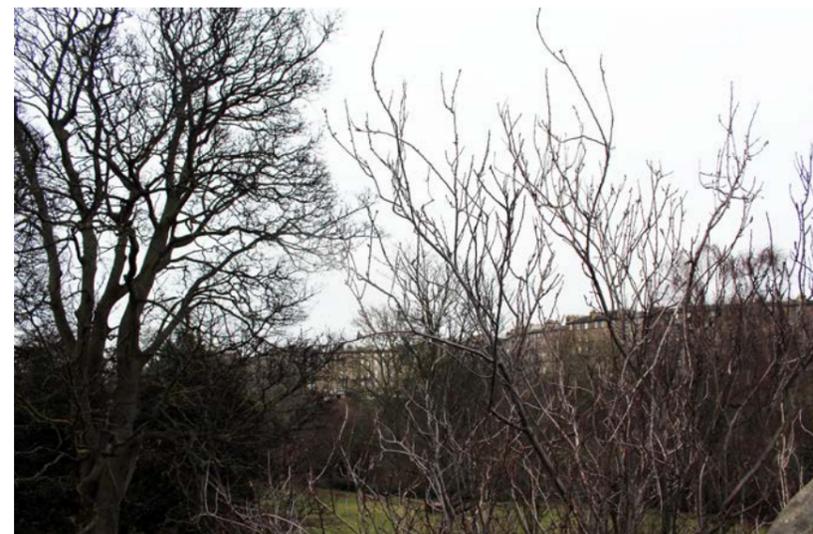
The historical view shown in the photograph below (fig.4) is no longer possible due to the mature trees in Dean Gardens. The wall along Dean Bridge is also fairly high which means the extensive views shown in the historical photo below is somewhat tempered.

Figure 4: View down the valley from Dean Bridge today obscured by trees

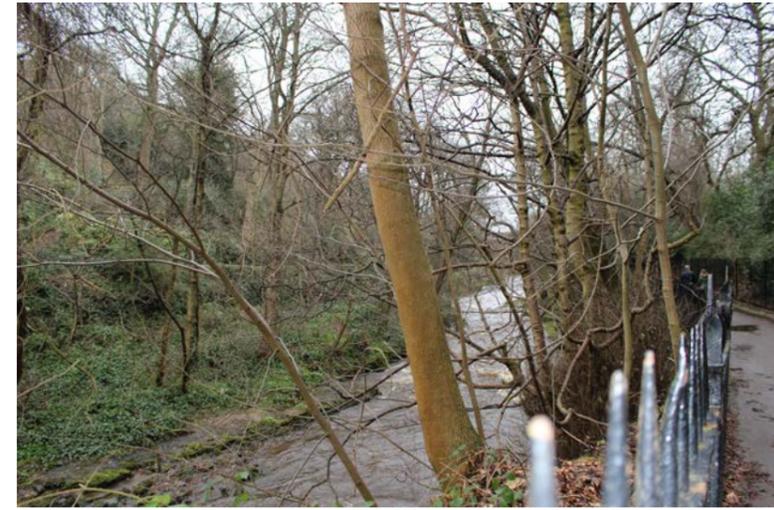
The historic photograph shows the view from the point where Greenland Mill stood; down towards St George's Well and St Bernard's Well. Given the state of St George's Well it could be argued that the view is now redundant. What the current photograph shows however, is just how overgrown the self-seeded banks have become. Should there be a desire to reinstate the view, it would benefit from the upgrading of railings and clearance of trees and vegetation in this vicinity.

Figure 7: The view today

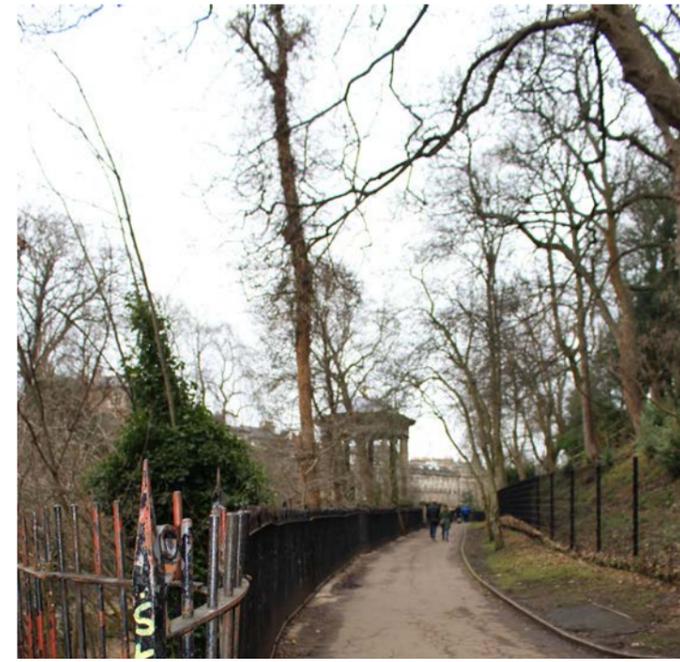
The view east towards St Bernard's Well is obscured by trees in directly to the side of the well as seen in figure 9. Removal of these would help restore the view of St Bernard's Well if traveling along the walkway from the west.

Figure 9: The view today

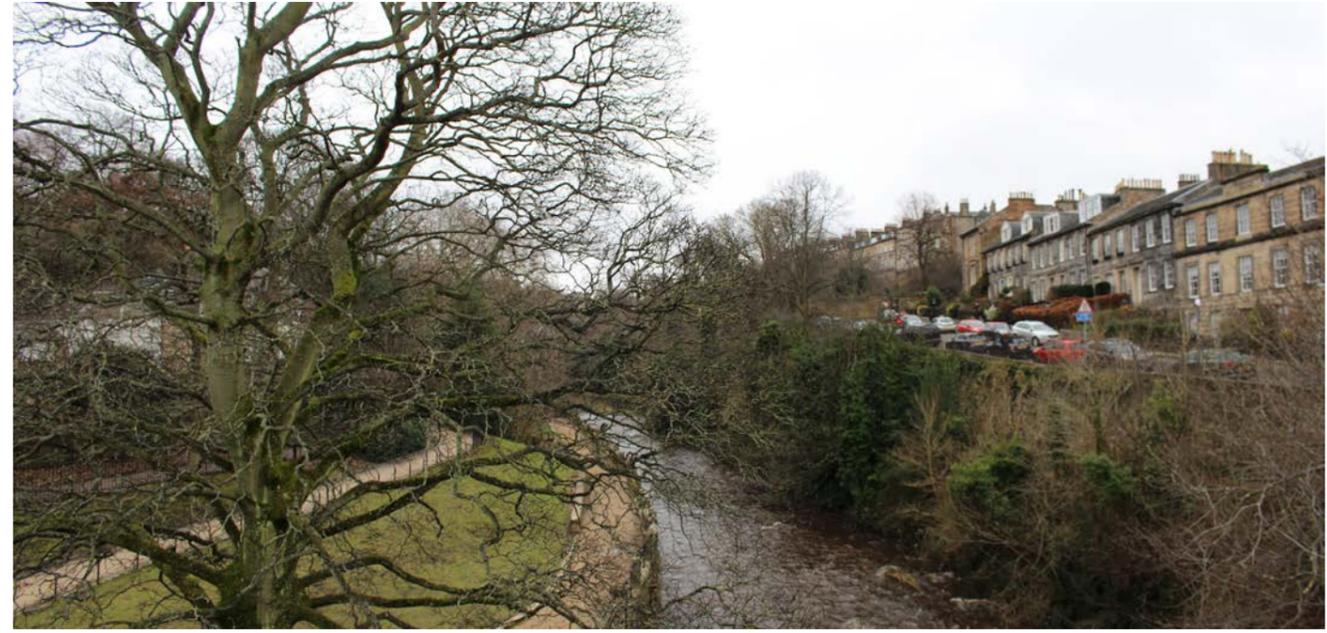
- 9.31 The historic depiction of St Bernard's Well, The Dean Bridge and the Dean Village beyond, in Joseph Brown's Dean valley from St Bernard's Bridge (c1896) suggests a clear, albeit perhaps romanticised view, very much unlike the one we see today. One particular tree in the foreground blocks the view immediately, and the trees beyond block any view to Dean Bridge. What the picture does show which is consistent with the current situation however, is an abundance of trees and vegetation surrounding St George's Well and the opposite bank. Views from the Bridge are not completely blocked however and would open with some maintenance (as suggested in View 17). The (Platanus sp.) specimen tree in the foreground may benefit from some pruning but is an attractive tree adding to the character of the valley currently and does not necessarily need to be removed, unless there was a wish for the exact historic view to be reinstated.

Figure 11: The View from St Bernard's Bridge today

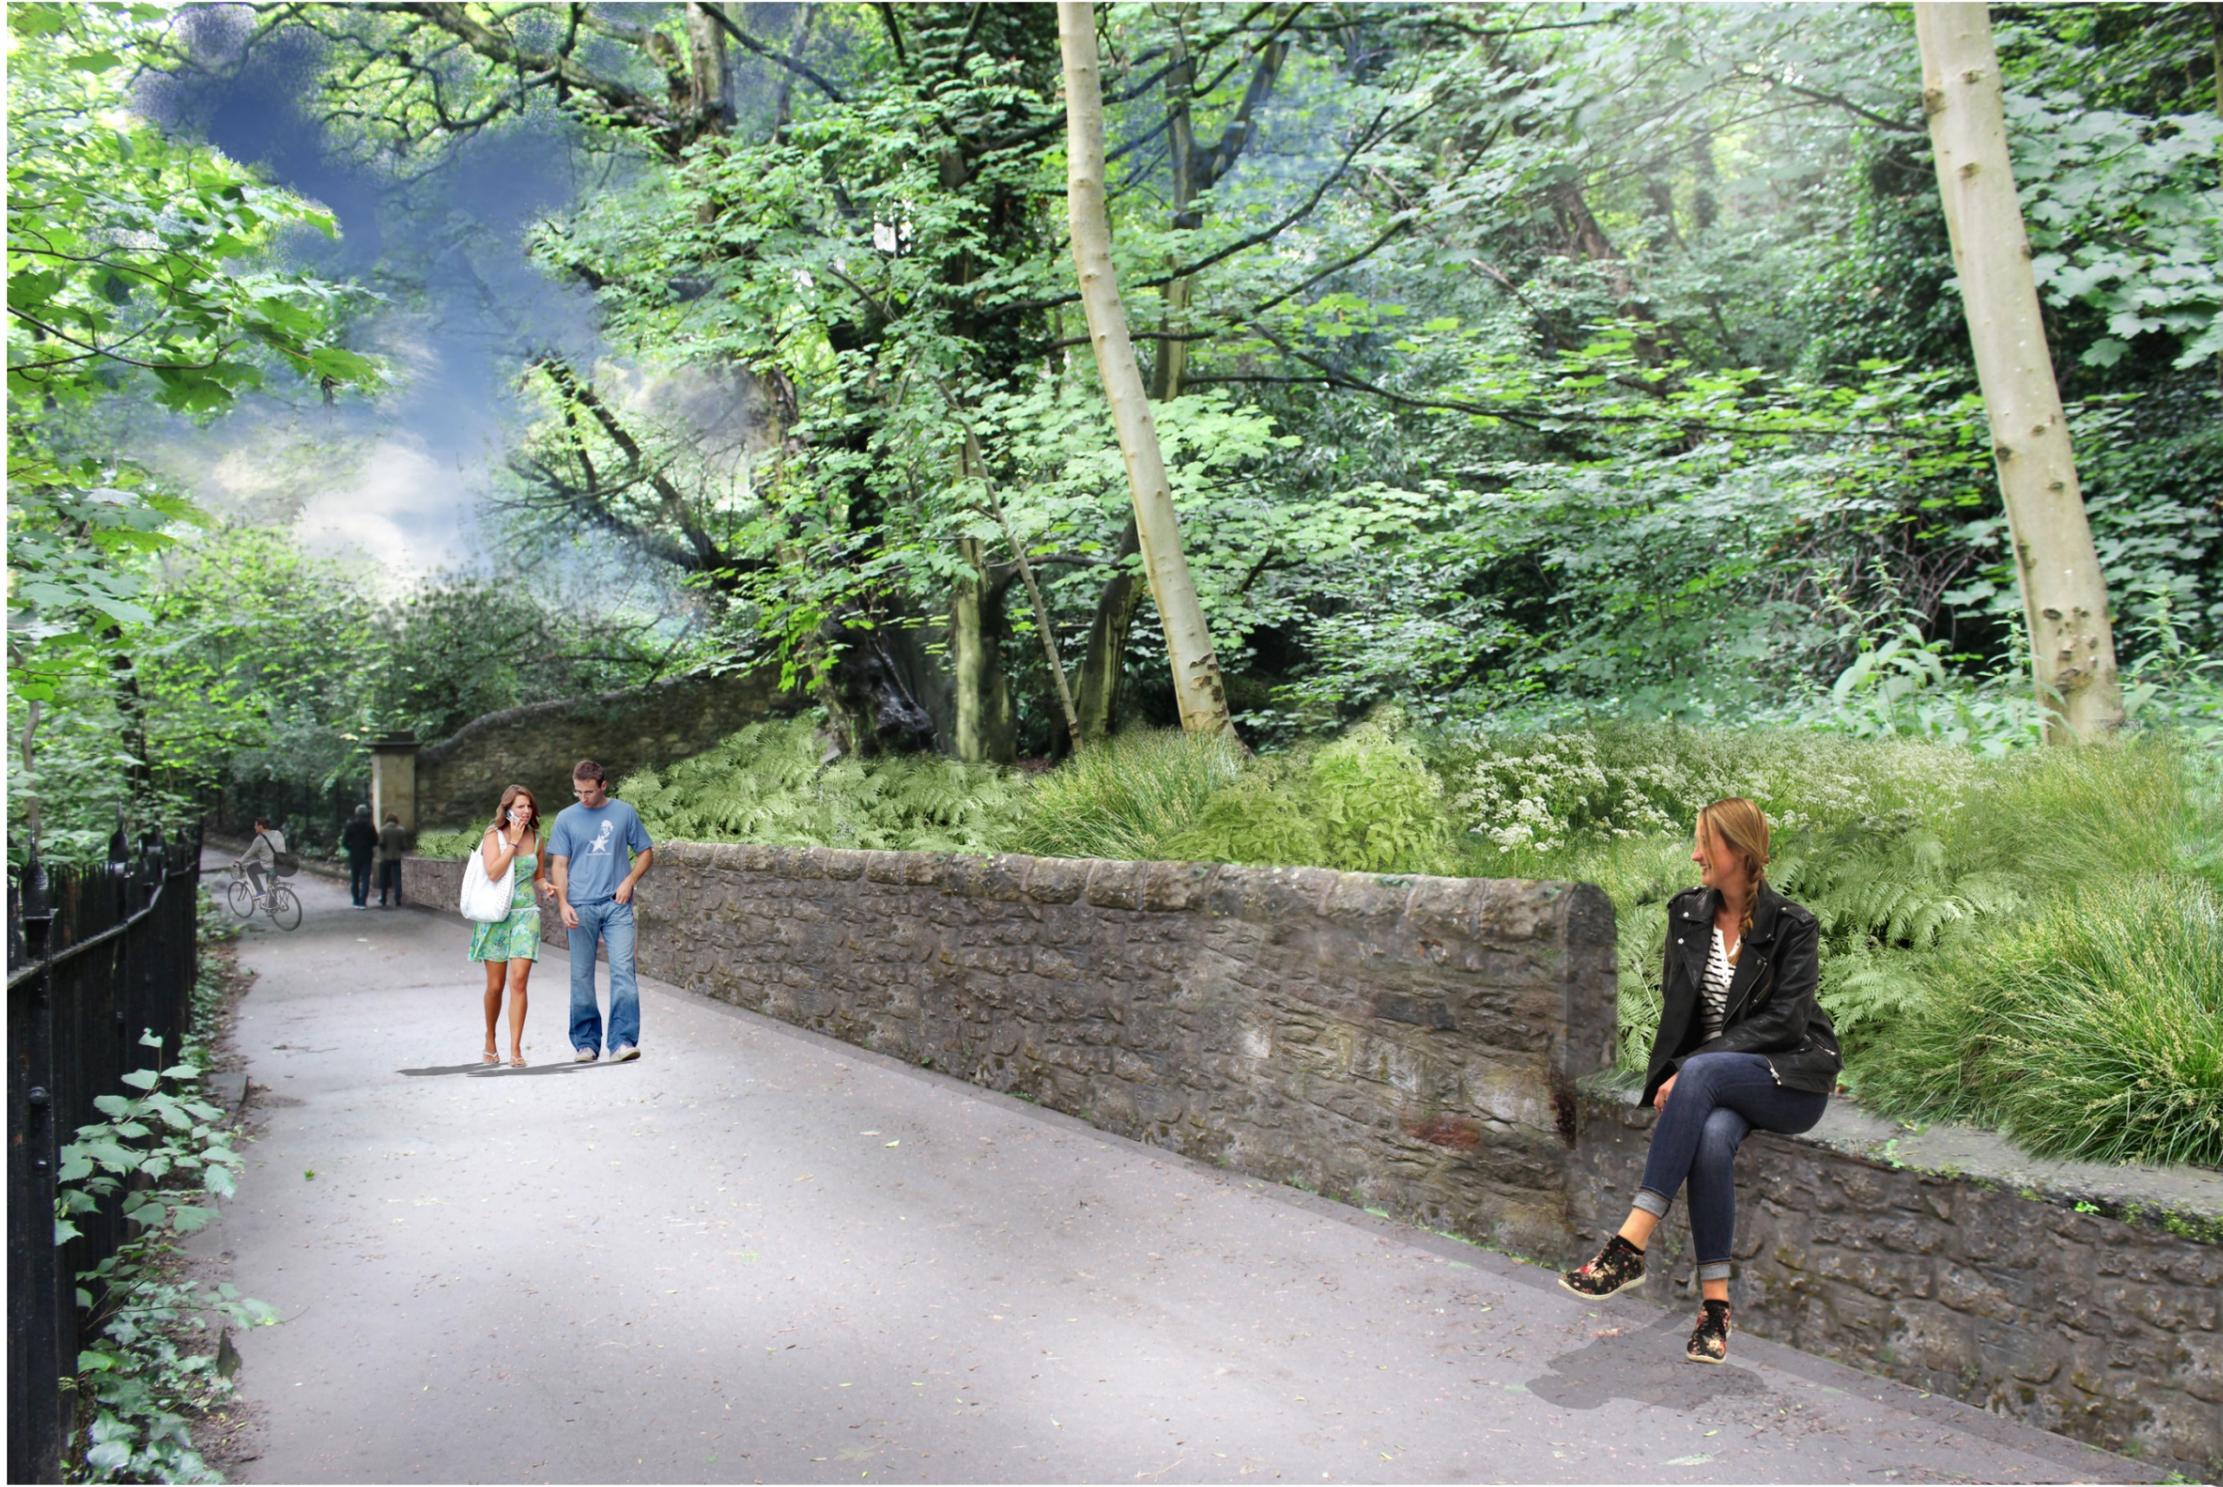
Figure 13: Conceptual visual illustrating proposals for 'Baxter's Land' with low maintenance planting and opening up of tree canopy

- 10.3 Proposals for this area have taken into account the practical and safety constraints of maintenance and access. They have also taken into account the feedback given by CEC staff with regards to maintenance issues and native planting. Figure 13 offers a conceptual image of what this area could look like if the proposals were carried out (including the pruning back of tree canopy mentioned elsewhere in this study).

- 10.4 The design aim is to recreate the atmosphere of nearby Dean Gardens and Moray Bank Gardens, both of which are transitions between an unmanaged area and an ornamental garden in their current state. This is an area where crown lifting and some selective clearance of existing saplings would benefit by allowing more light into the terraced former garden areas, providing a better environment for establishing plants and relieving the gloom under the large heavy canopy trees. The planting strategy takes into consideration the need for low maintenance and the shaded conditions; CEC have also requested predominantly native planting. Swathes of ferns, grasses, shade tolerant ground cover and perennials are proposed to will create an attractive understorey fitting to its context, next to the cliff face.
